# City of Commerce City Honnen Building Assessment

Facility Condition Assessment Report | FINAL

COMMERCE CITY, COLORADO

MAY 15, 2020

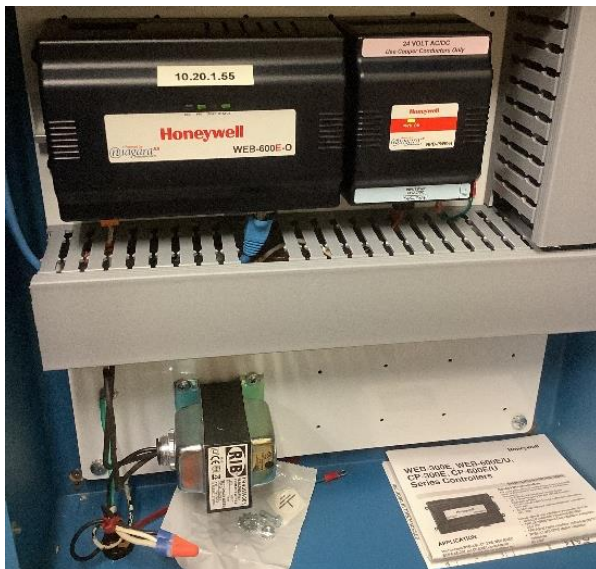
As previously mentioned, the BAS controllers are located on-site, but the front-end workstation of the BAS currently resides offsite at the Adams County Human Services Building. There is a newer Honeywell JACE located in the IT Room, and the 16 RTUs are each equipped with their own Honeywell FAC control module. Control programs (operation, set points, occupancy schedules, etc.) reside within the JACE. However, the front-end software interface is required to monitor and operate the BAS. Integration of the Honnen Building BAS into the Commerce City automation systems or installation of a front-end workstation computer at the site are two options to consider. The estimated cost of BAS front-end software integration into the Commerce City BAS has been supplied by the Commerce City IT Department.

Honeywell N-4 JACE on-site

Estimated cost of BAS front-end software and on-site workstation: \$8,250

Estimated cost of BAS front-end software integration into City BAS: \$20,000

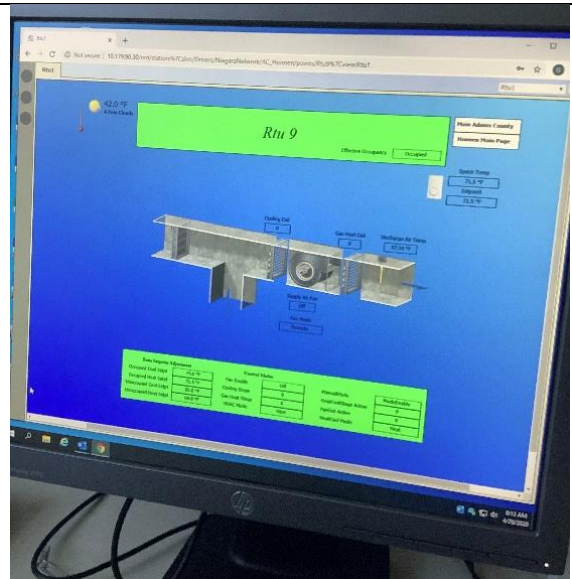
Photo of Building BAS off-site

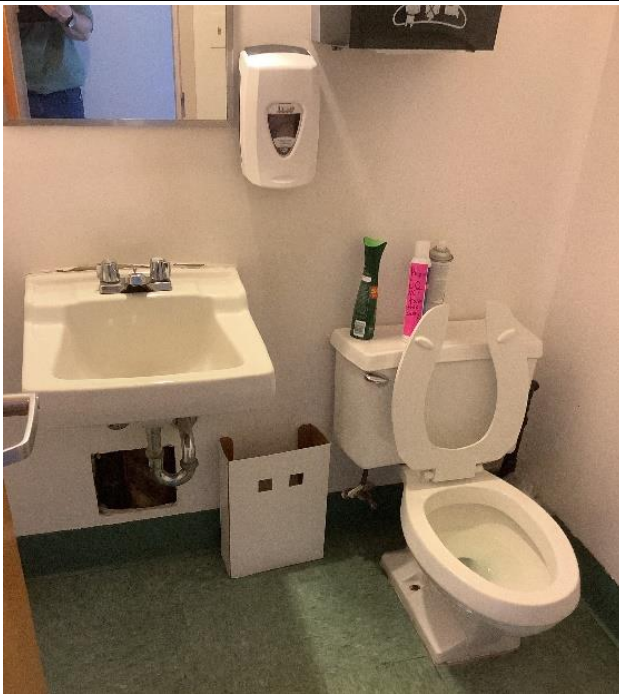
Eleven bathrooms are non-ADA (Americans with Disabilities Act) compliant, and will require remodeling to bring them into compliance. Some bathrooms are equipped with grab bars, but none have fully ADA-compliant toilets, lavatories, or fixtures. ADA Guidelines for Buildings and Facilities sections 4.16 (Toilets) and 4.19 (Lavatories) requires that there be at least one ADA compliant bathroom on each floor. Not all bathrooms are required to be ADA compliant, but if a bathroom were to be remodeled it does have to be remodeled to ADA standards at that time.

Non—compliant restroom

Estimated cost to remodel bathroom to ADA compliance (\$9,000 per bathroom): \$99,000

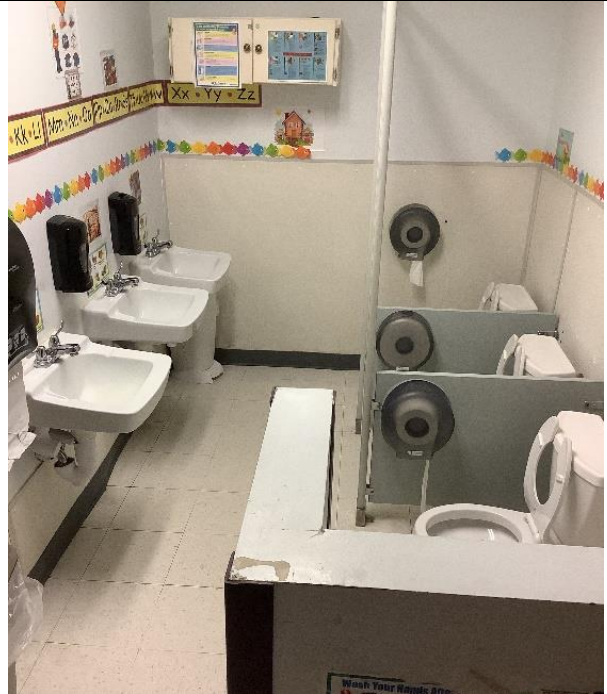
Specialized restroom, not ADA-accessible

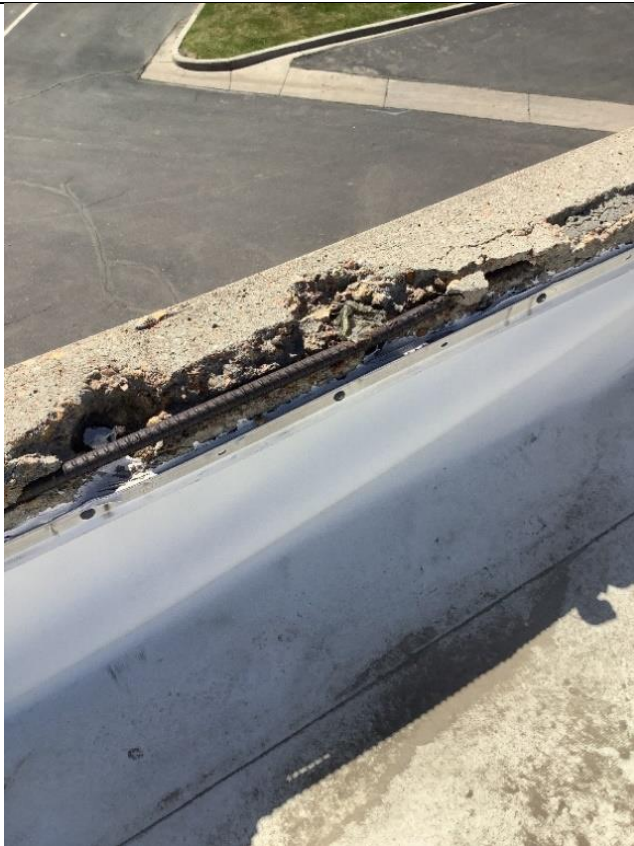
The exterior cast concrete walls will not require replacement for an estimated 30 years. However, several localized sections require immediate repair. Per Adams County, these cast concrete wall sections are re-sealed every 12 years, and were last re-sealed in 2012. They are due for re-sealing again in 2024.

Localized wall damage

Estimated cost for 500 SF of repair to cast concrete wall: \$16,205

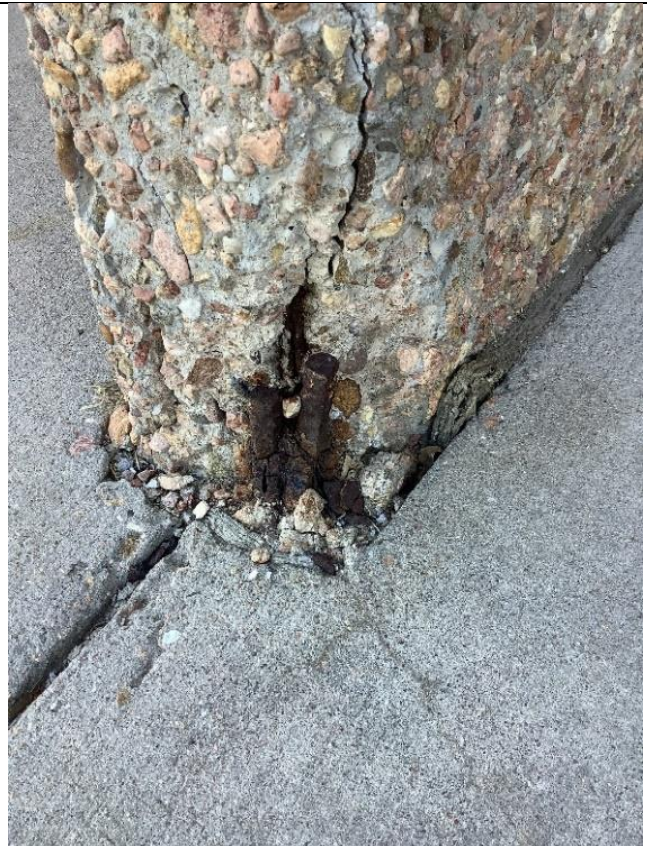
Localized ground-level wall damage

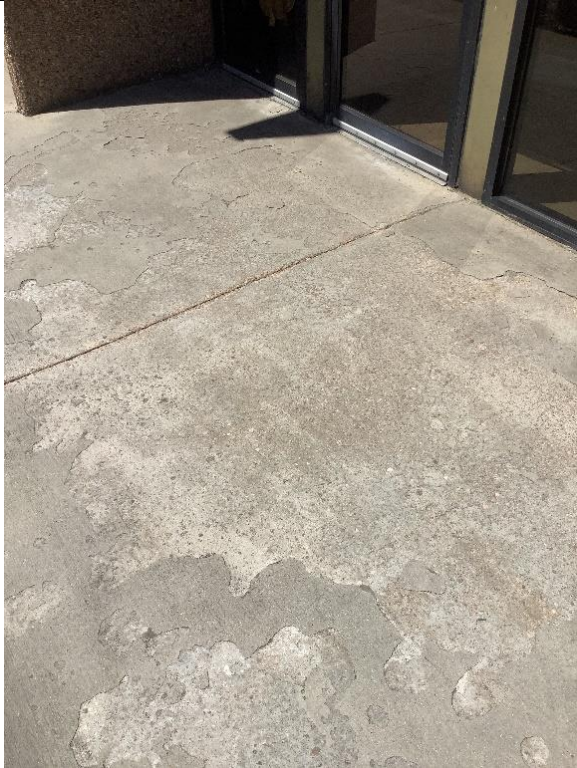
Concrete sidewalks are cracked due to weather exposure and salt. Recommend repairing damaged sections, as they represent potential safety/tripping hazards. Sidewalks are estimated to not require total replacement until 2035.

Localized surface spalling due to salt

Estimated cost 500 SF of concrete walkway repair: \$3,085

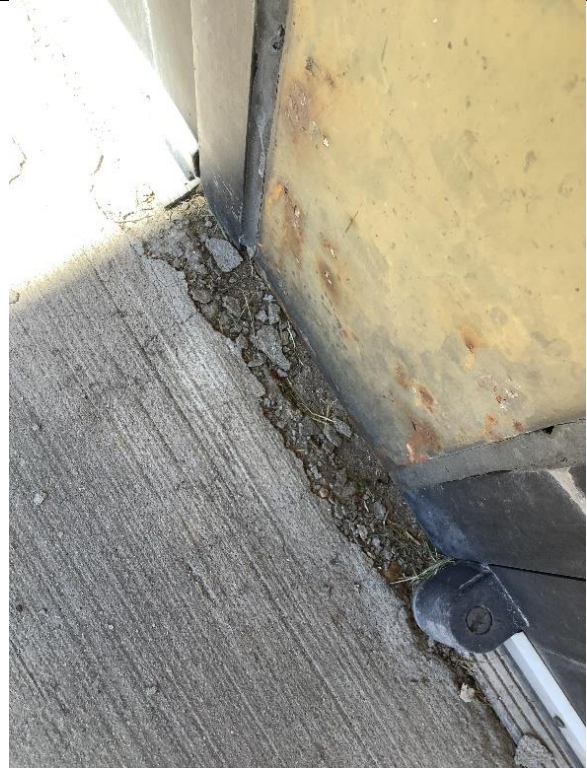
Localized sidewalk damage

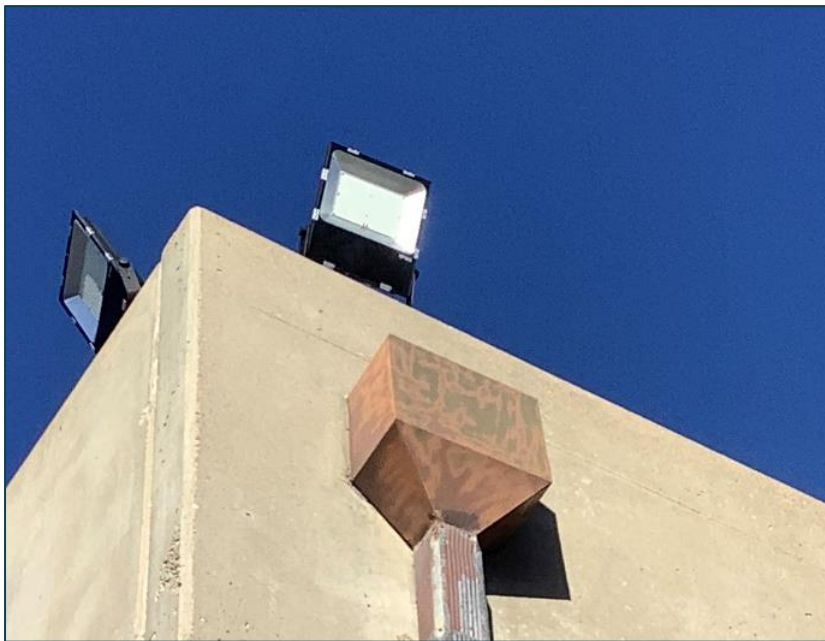
Four(4) 23' long downspouts are in average condition for age, but require re-painting to prevent corrosion.

Downspouts on building

Estimated cost to paint downspouts: \$1,280

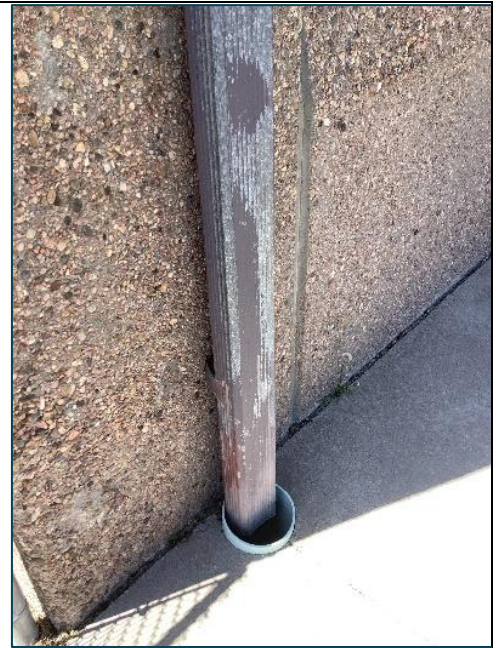
Grade-level drain

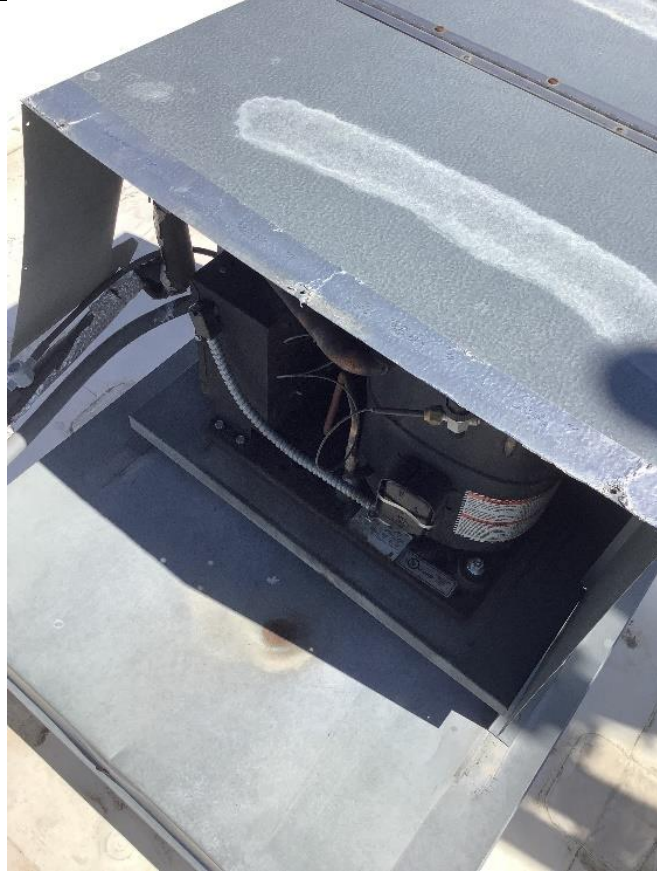
CU-3, serving Walk-in Cooler -3 in the Food Bank warehouse is in very poor condition. Panels are missing and the condenser coil is taped together. Replace within one year of purchase.

Missing panels on condensing unit

Estimated cost to replace 2-ton condensing unit: \$2,686

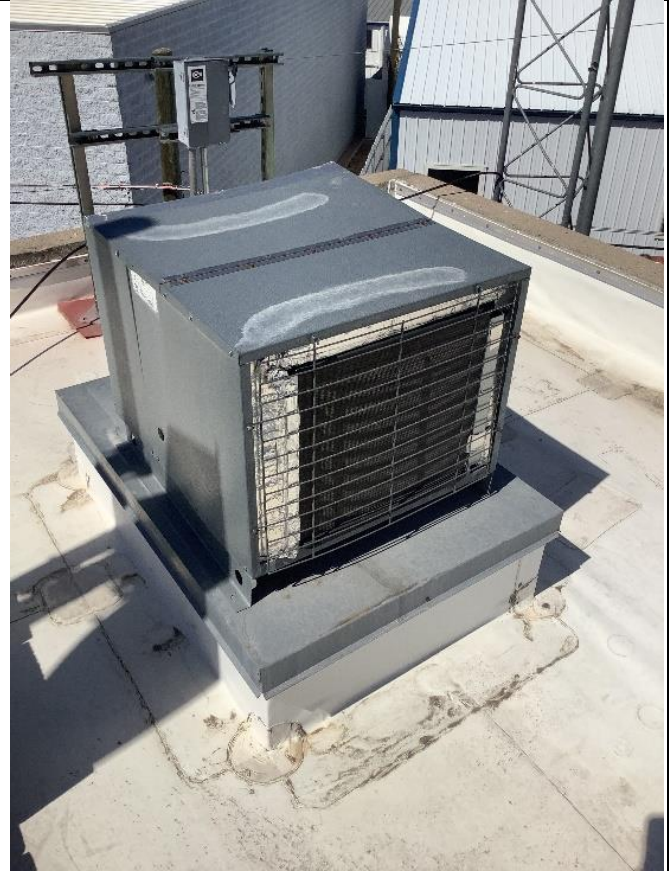
Condenser coil held in place with metallic tape

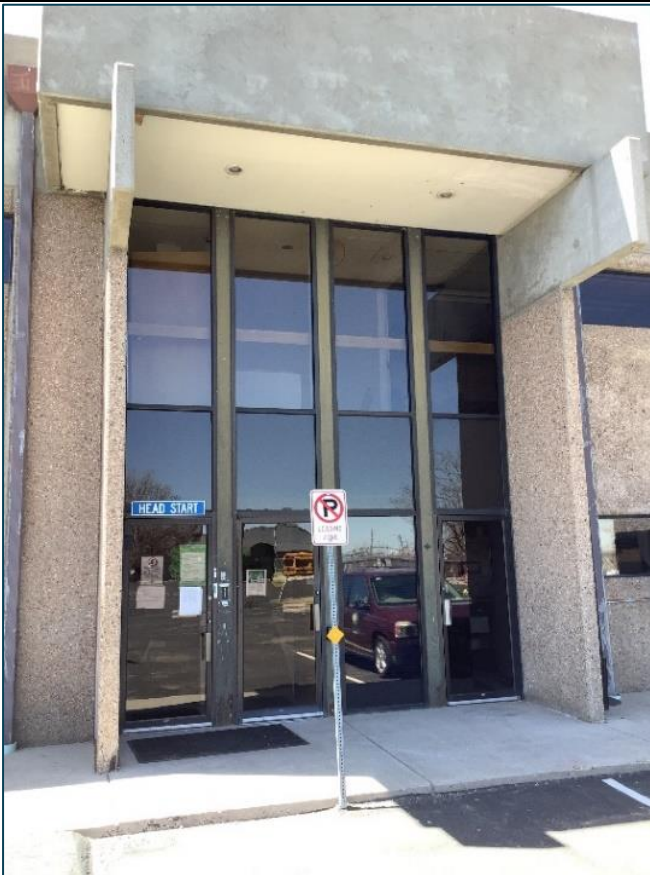
The three (3) sections of storefront doors located at the three (3) main entrances date to 1998. Metal doors, and especially the sections between doors, are rusted due to weather exposure and salt. Storefront doors are due to be replaced in 2022.

Typical storefront doors

Estimated cost to replace (9) storefront exterior doors: \$35,520

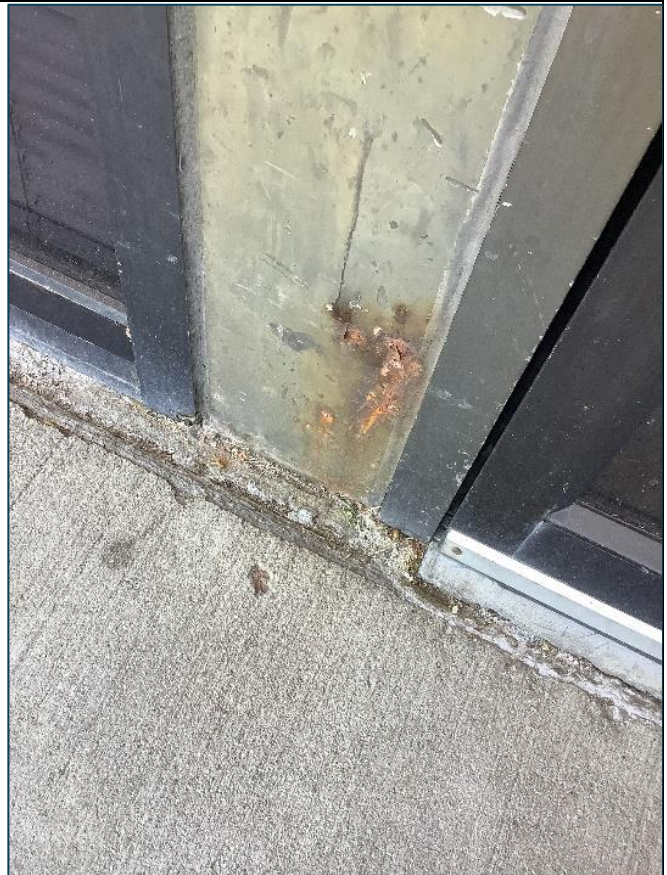
Localized corrosion adjacent to door frame

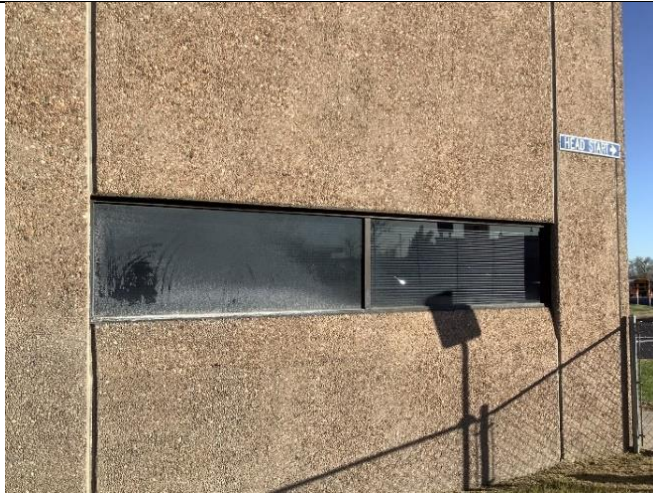
All exterior windows were replaced in 1998. Per Adams County, windows are re-sealed every 12 years which was last completed in 2012. Windows are due to be replaced approximately 2025.

Typical exterior window

Estimated cost to replace (3) sections of (15' x 18' of aluminum exterior windows above storefront doors: \$29,802

Estimated cost to replace (24) 3' x 16' aluminum frame exterior windows: \$127,157

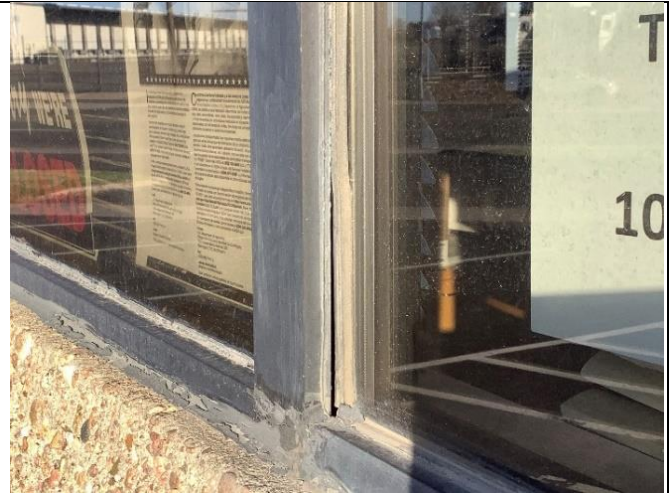
Localized seal failure

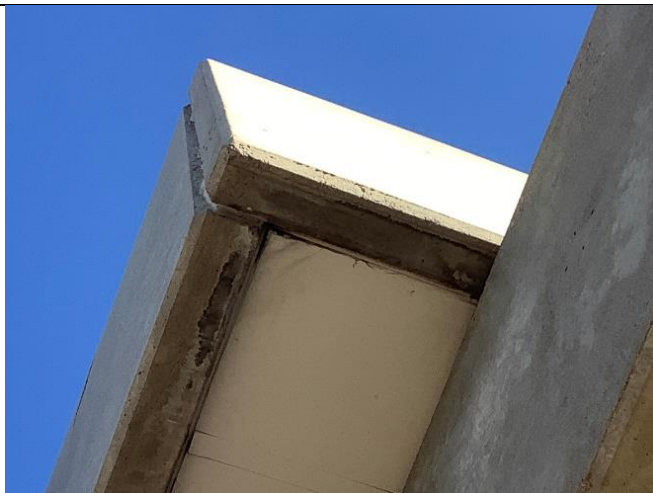
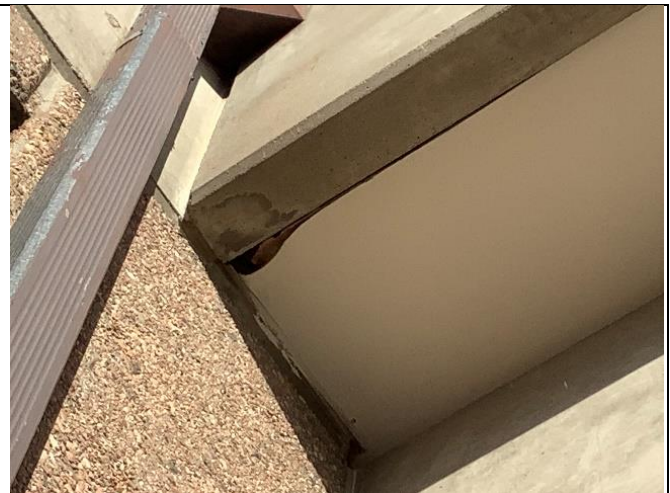
Three sections of exterior soffits require repairs due to water damage. The estimated cost to repair exterior soffits (hoist required): \$2,025

Water-damaged soffits

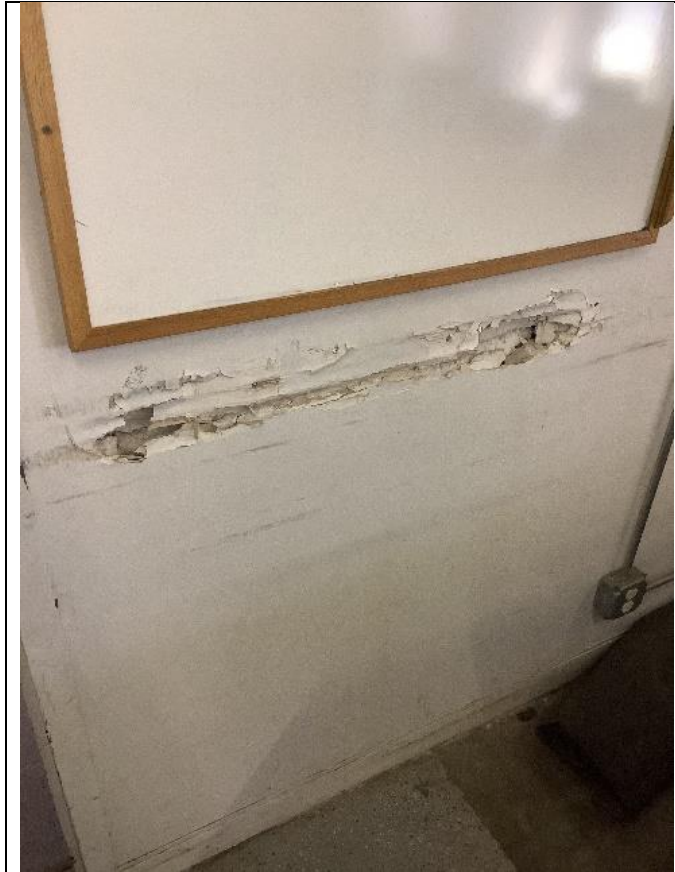
Minor drywall patching is required, mostly in the Food Bank Warehouse.

Damaged drywall

Estimated cost to repair interior drywall (labor and materials): \$680

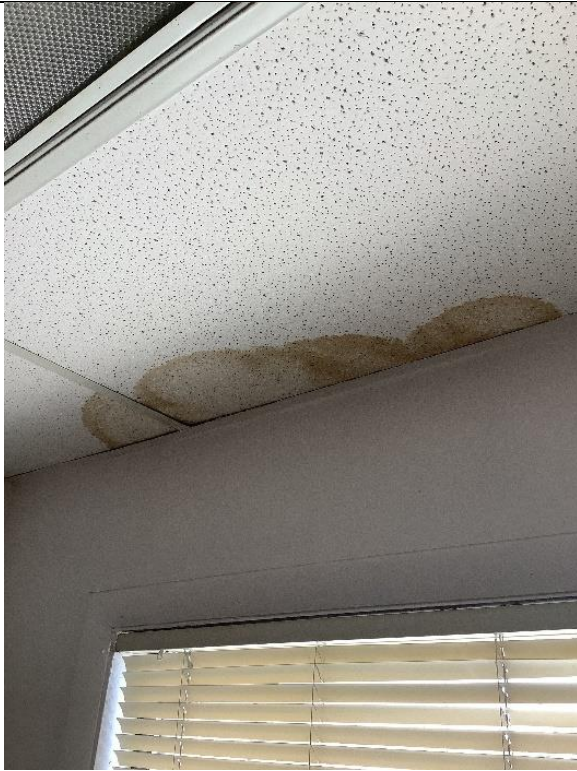
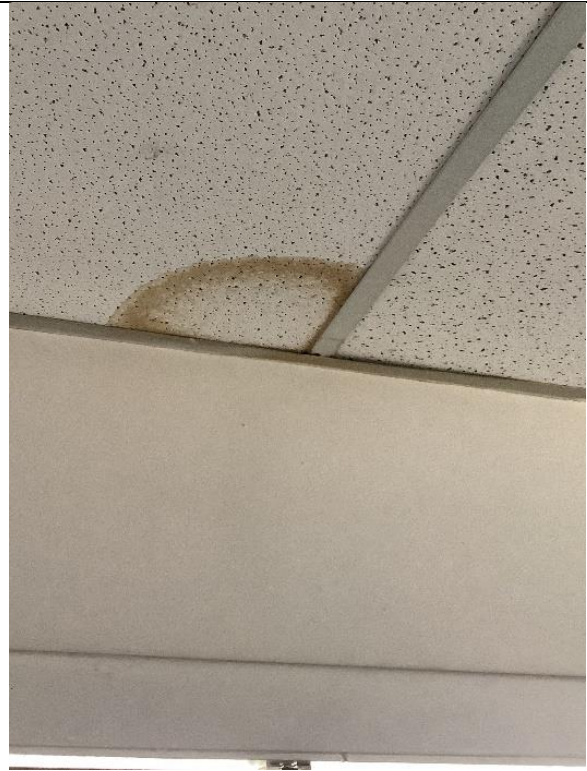
Approximately 25 acoustic ceiling tiles need to be replaced throughout the building due to staining or water damage.

Water-stained ceiling tiles

Estimated cost to replace acoustic ceiling tiles: \$482

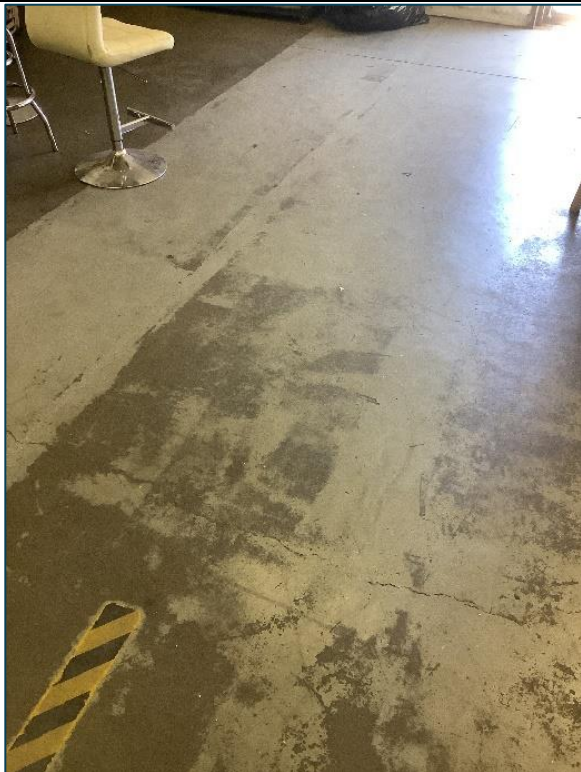
Sealed concrete flooring located in the Food Bank warehouse requires minor patching and a complete re-seal. Carpet in the Honnen Building is newer and in good condition. Tile flooring dates to 1998 and is in average condition.

Minor cracking in concrete floors

Estimated cost to patch and re-seal 2,700 SF of Food Bank warehouse floor: \$13,473

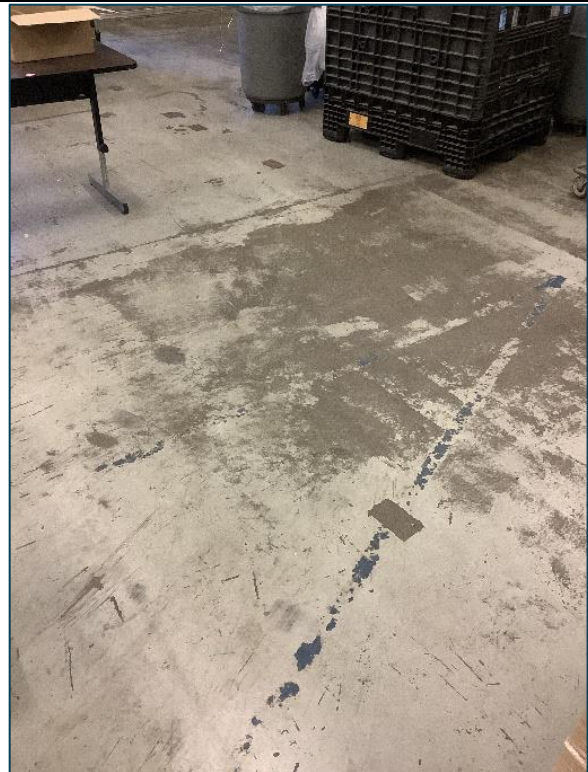
Surface finish wear on concrete floor
