RE: June 2024 Full Scope Site Inspection at Tower Landfill, Commerce City, Colorado

INSPECTION REPORT

Date: June 24, 2024

Site: Tower Landfill
8480 Tower Road
Commerce City, CO 80022

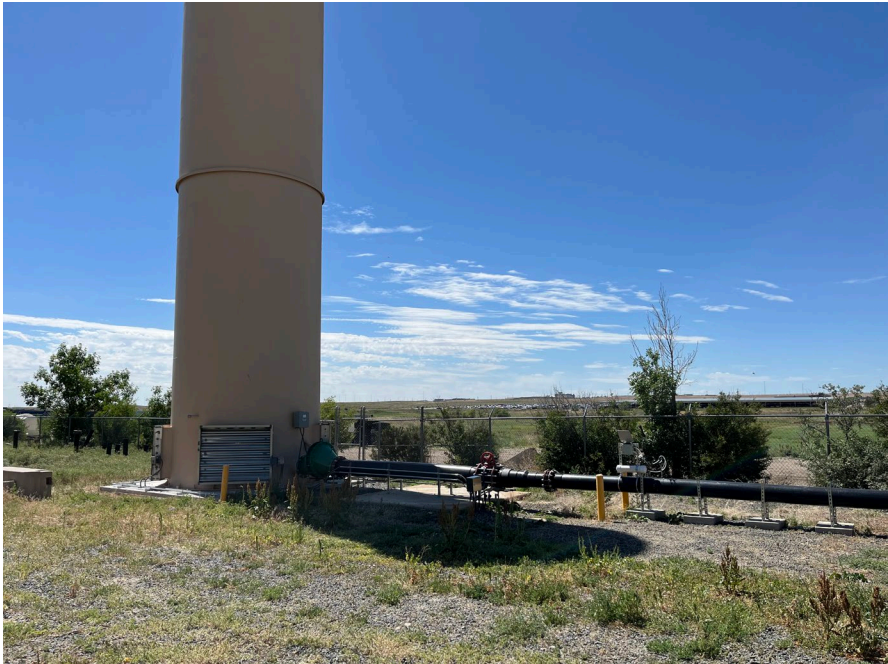
After the records review was completed, the inspection team went to the garage and loaded into a Republic Services pickup truck. The pickup was driven by Daniel Bargmann with passengers Vittoria Zucchelli, Steve Derus, Mike Weakley and Larry Bruskin. The first stop was the gas flare (Picture 1), located just east of the office building inside the fence line. Located between the gas flare and the office building is a shed containing blowers (Picture 2) and other equipment necessary to operate the

Picture 1: Gas Flare Looking Southeast

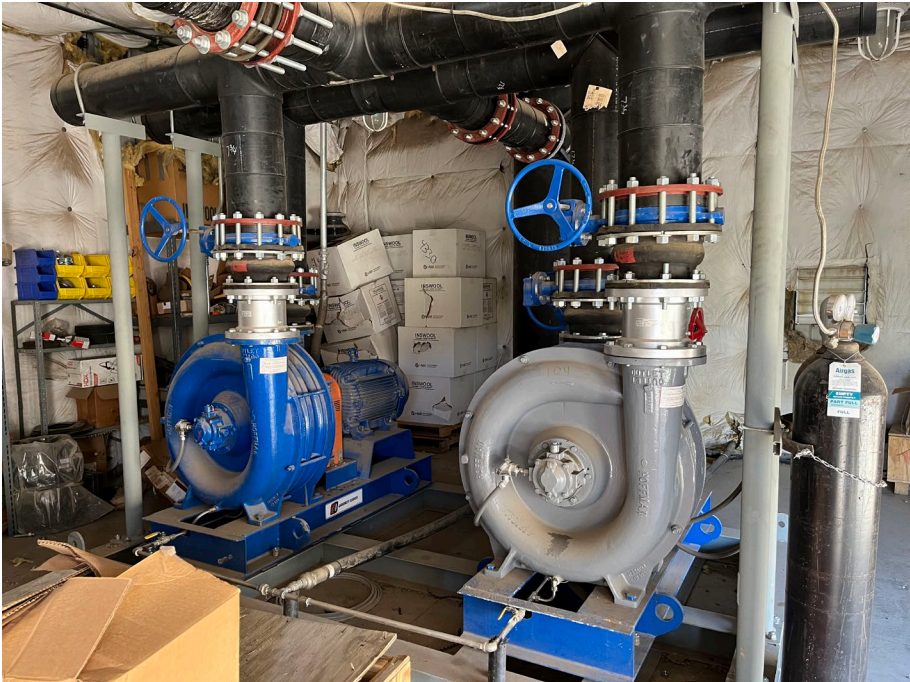
gas flare properly. The entire system is automated such that it will shut down if an upset condition occurs rather than venting gas directly to the atmosphere.

Picture 2: Blowers for Gas Flare Inside Shed

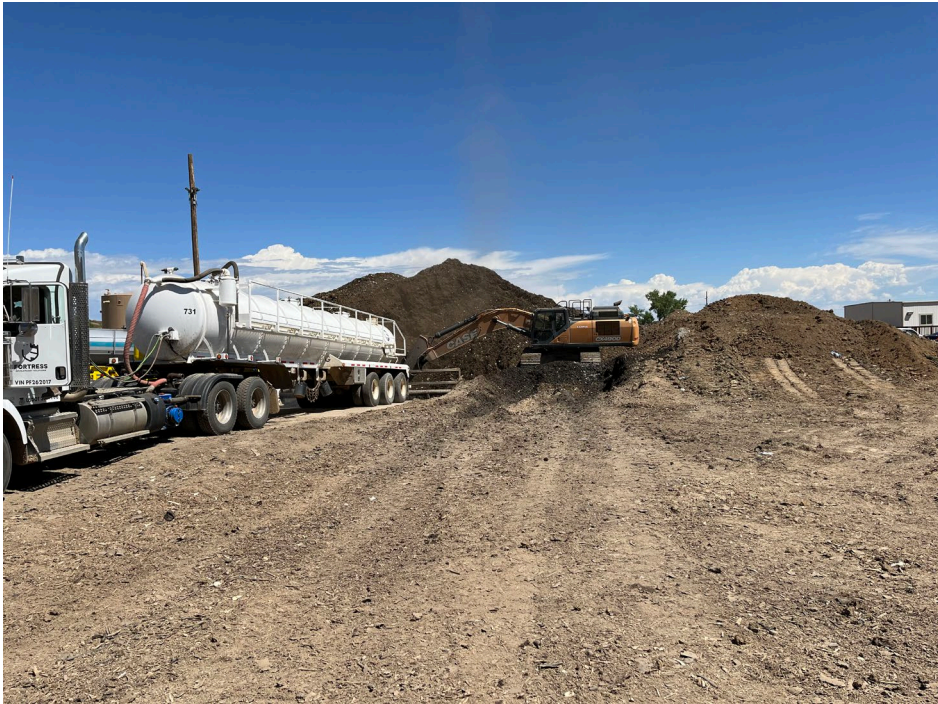
The truck left the gas flare area and traveled north on Tower Road then east on E 88th Avenue and turned south into the main entrance for the landfill. We bypassed the scale and gatehouse and drove towards the solidification basin (Picture 3), which was in operation at the time of the inspection. As shown in Pictures 3, a tanker truck was unloading liquid waste material into the basin while an excavator mixed the liquid with solidifying agents, including clay soil, auto shredder fluff, and wood chips. Once the mix is solidified and able to pass the paint filter test it will be disposed in the landfill.

Picture 3: Solidification Basin In Use Looking North

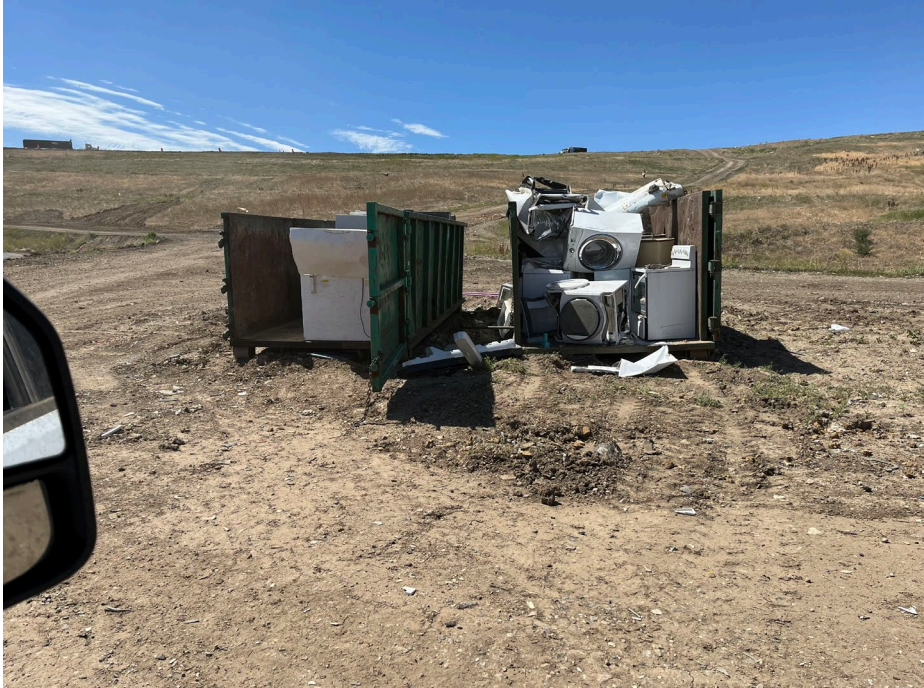
The truck then drove towards the main road ascending the landfill, passing the “white goods” storage area (Picture 4). As shown in Picture 4, the appliances requiring freon to be removed, such as refrigerators and freezers, are segregated from the other appliances and kept in the left storage bin until a licensed technician removes the freon. The truck ascended the main landfill access road and reached the top deck, passing the construction and demolition (C&D) debris area (Picture 5), the asbestos disposal area, and the working face for non-commercial waste disposal (Picture 6).

Picture 4: White Goods Storage Looking South

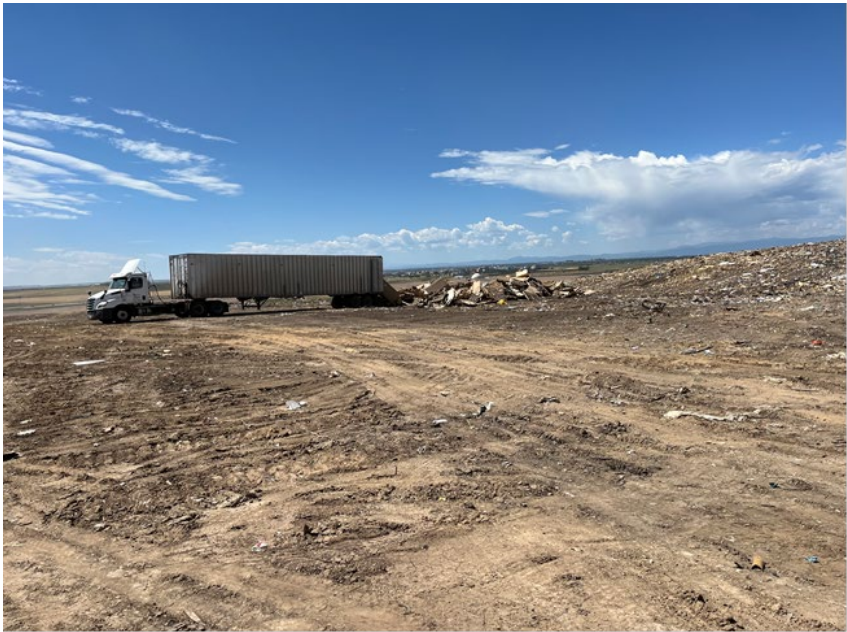
Picture 5: Construction and Demolition Debris Disposal Area Looking Southwest

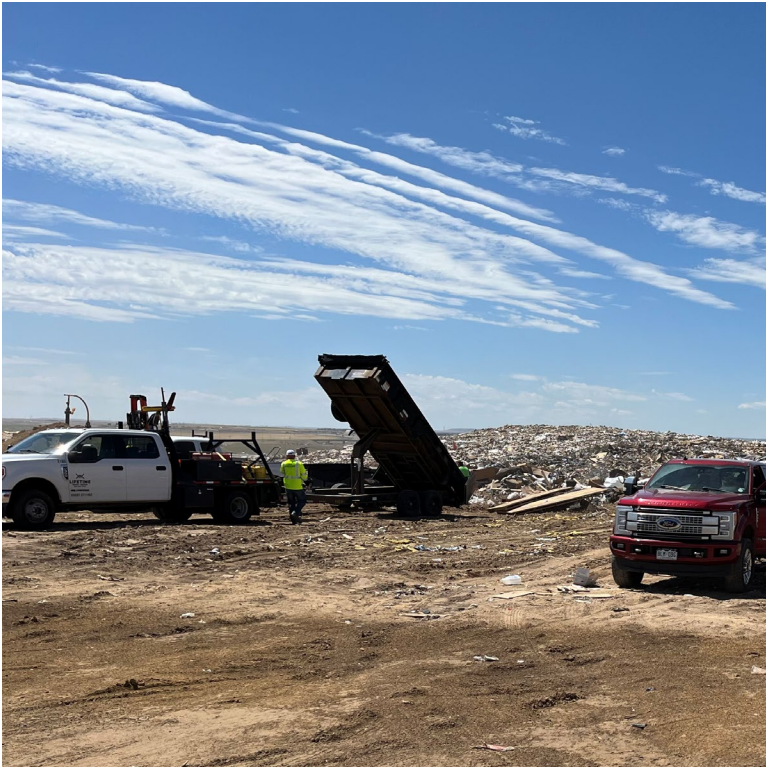
Picture 6: Non-Commercial (Public) Working Face Looking Southeast

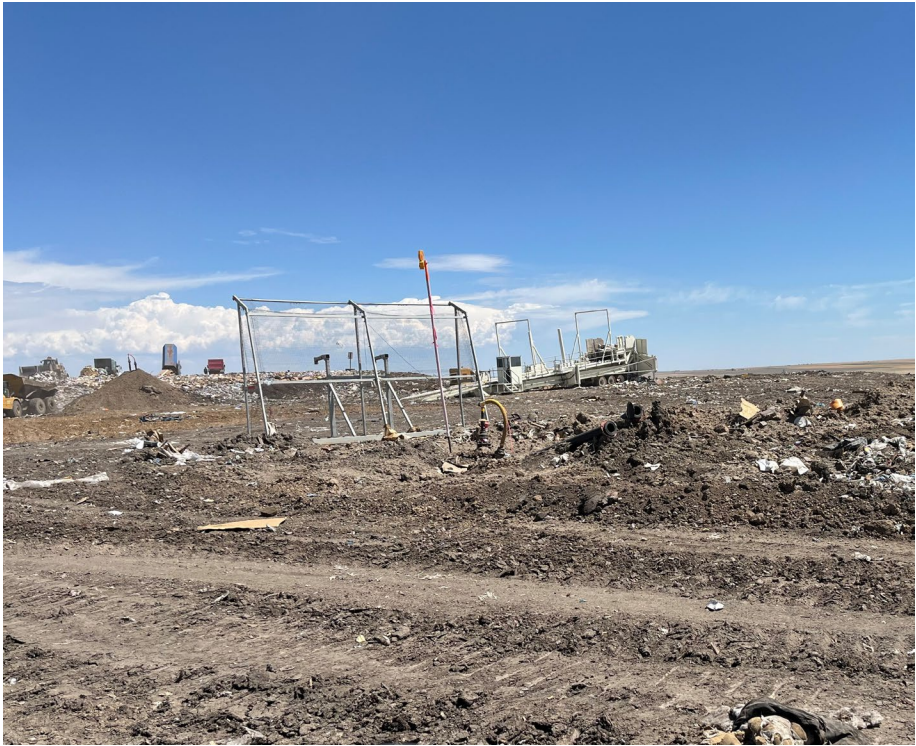
The inspection traveled to the municipal solid waste (MSW) working face where commercial haulers and transfer trucks unload their waste (Pictures 7 and 8). Heavy compactors are then used to spread and compact the waste before the next waste lift is placed. Close to the working face was a well with riser pipe and soil mound protection (Picture 9). Riser pipes are added to wells to account for increasing elevation of the surrounding waste. Treated medical waste (Picture 10) is disposed in a separate area near the MSW working face after it has been autoclaved, profiled, and manifested.

Picture 7: MSW Working Face Looking Northeast

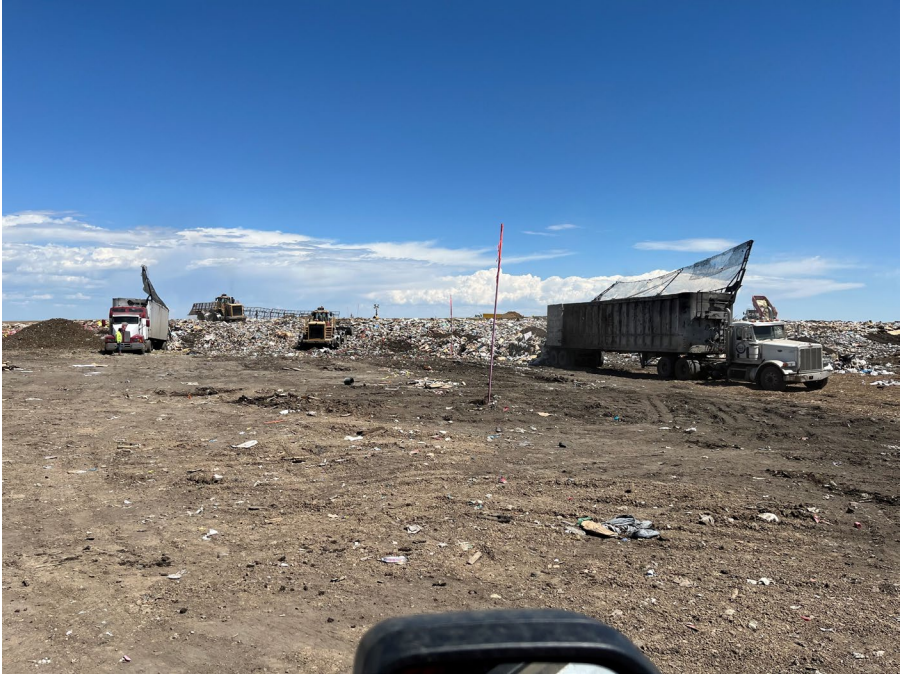
Picture 8: MSW Working Face Looking Northeast

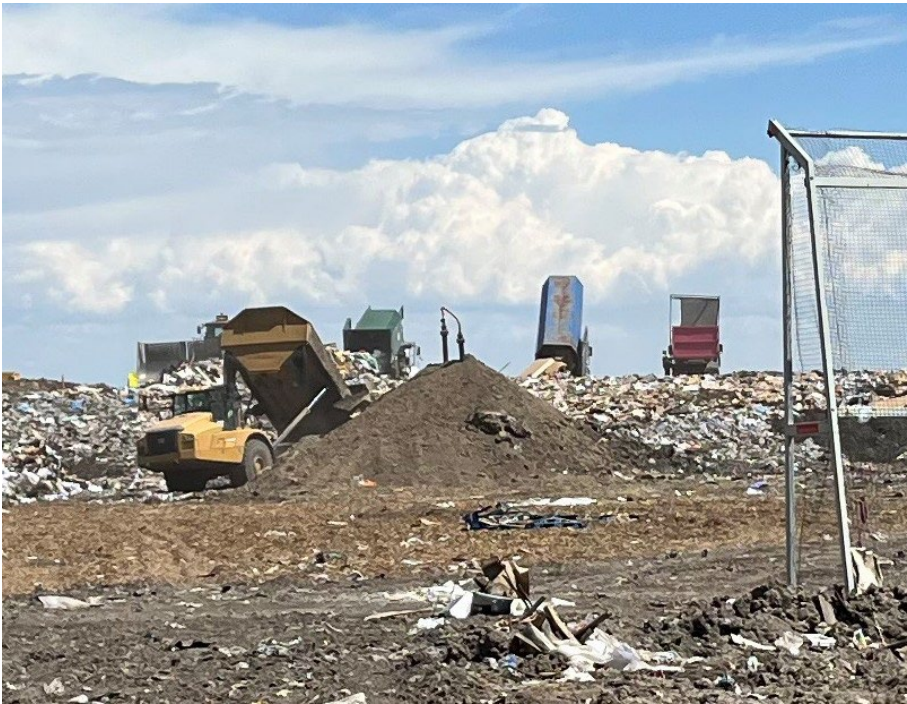
Picture 9: Well with Riser and Soil Barrier Looking North

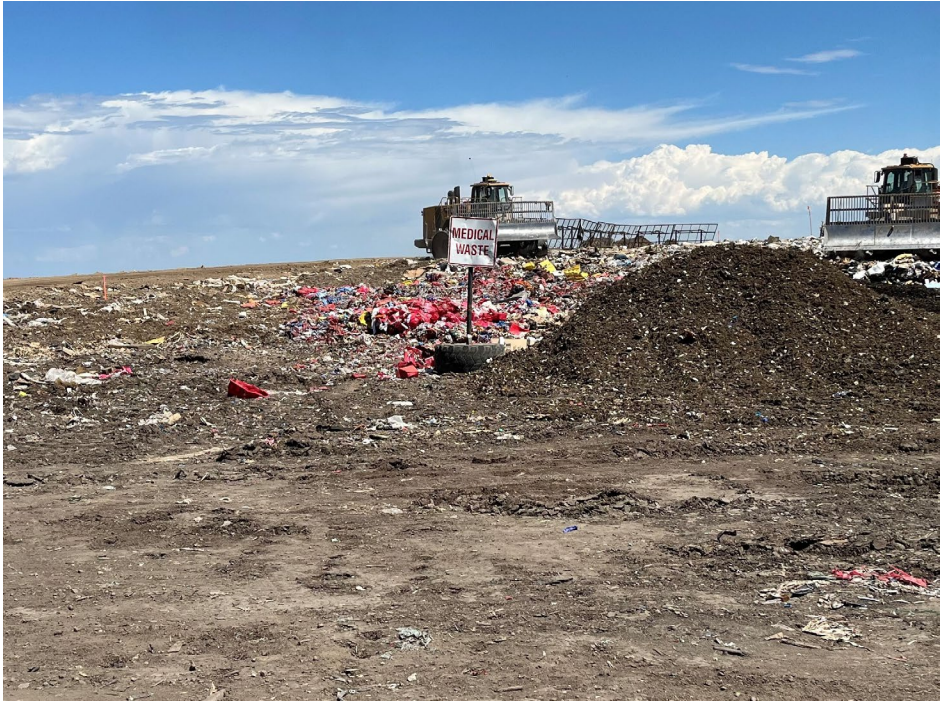
Picture 10: Treated Medical Waste Disposal Area Looking North

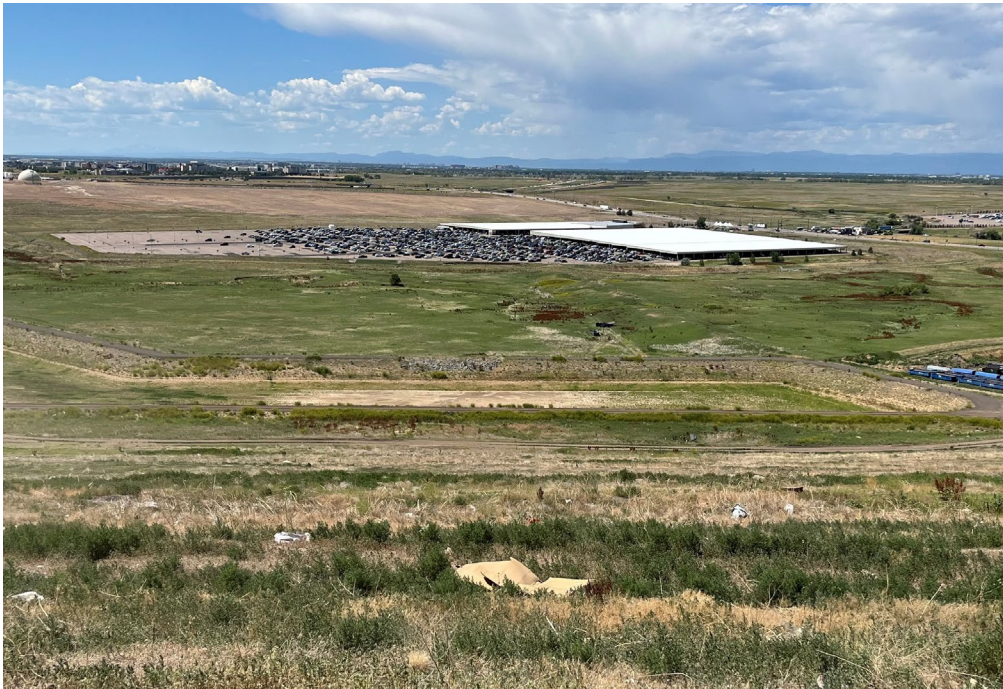
The truck drove south passing a vantage point to view the retention basin (Picture 11). The retention basin is currently totally dry. The dry basin contrasts with a year ago (Picture 12), when the area received almost daily rainstorms and the retention basin was nearly full with up to 8-feet of water depth. The final stop prior to heading back to the office was to view the location of the proposed new cell to be constructed this summer and fall (Picture 13). The approximate 15-acre cell is located along the southern and eastern sides of the current landfill footprint.

Picture 11: Retention Pond Totally Dry Looking Southwest

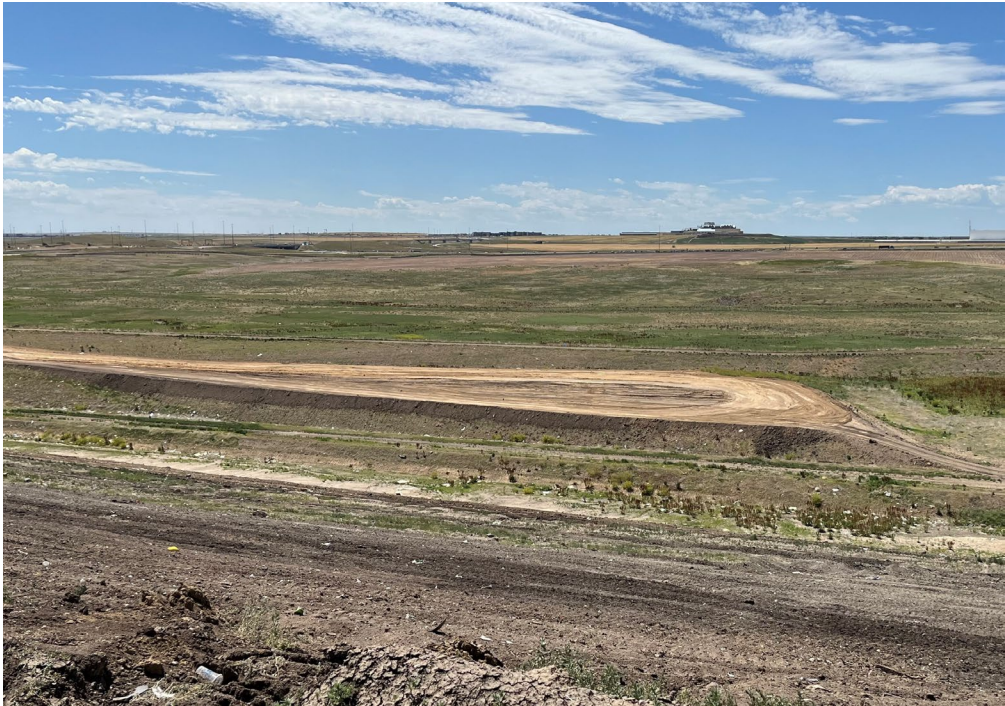
Picture 13: Location of Proposed New Cell Looking East
