Biological Resource Technical Memorandum

Date: November 15, 2022
To: Craig Lamacraft, Denver Water
From: Becky Burink, Biologist, Pinyon Environmental, Inc.
Subject: Denver International Airport/E-470 Pipeline Project

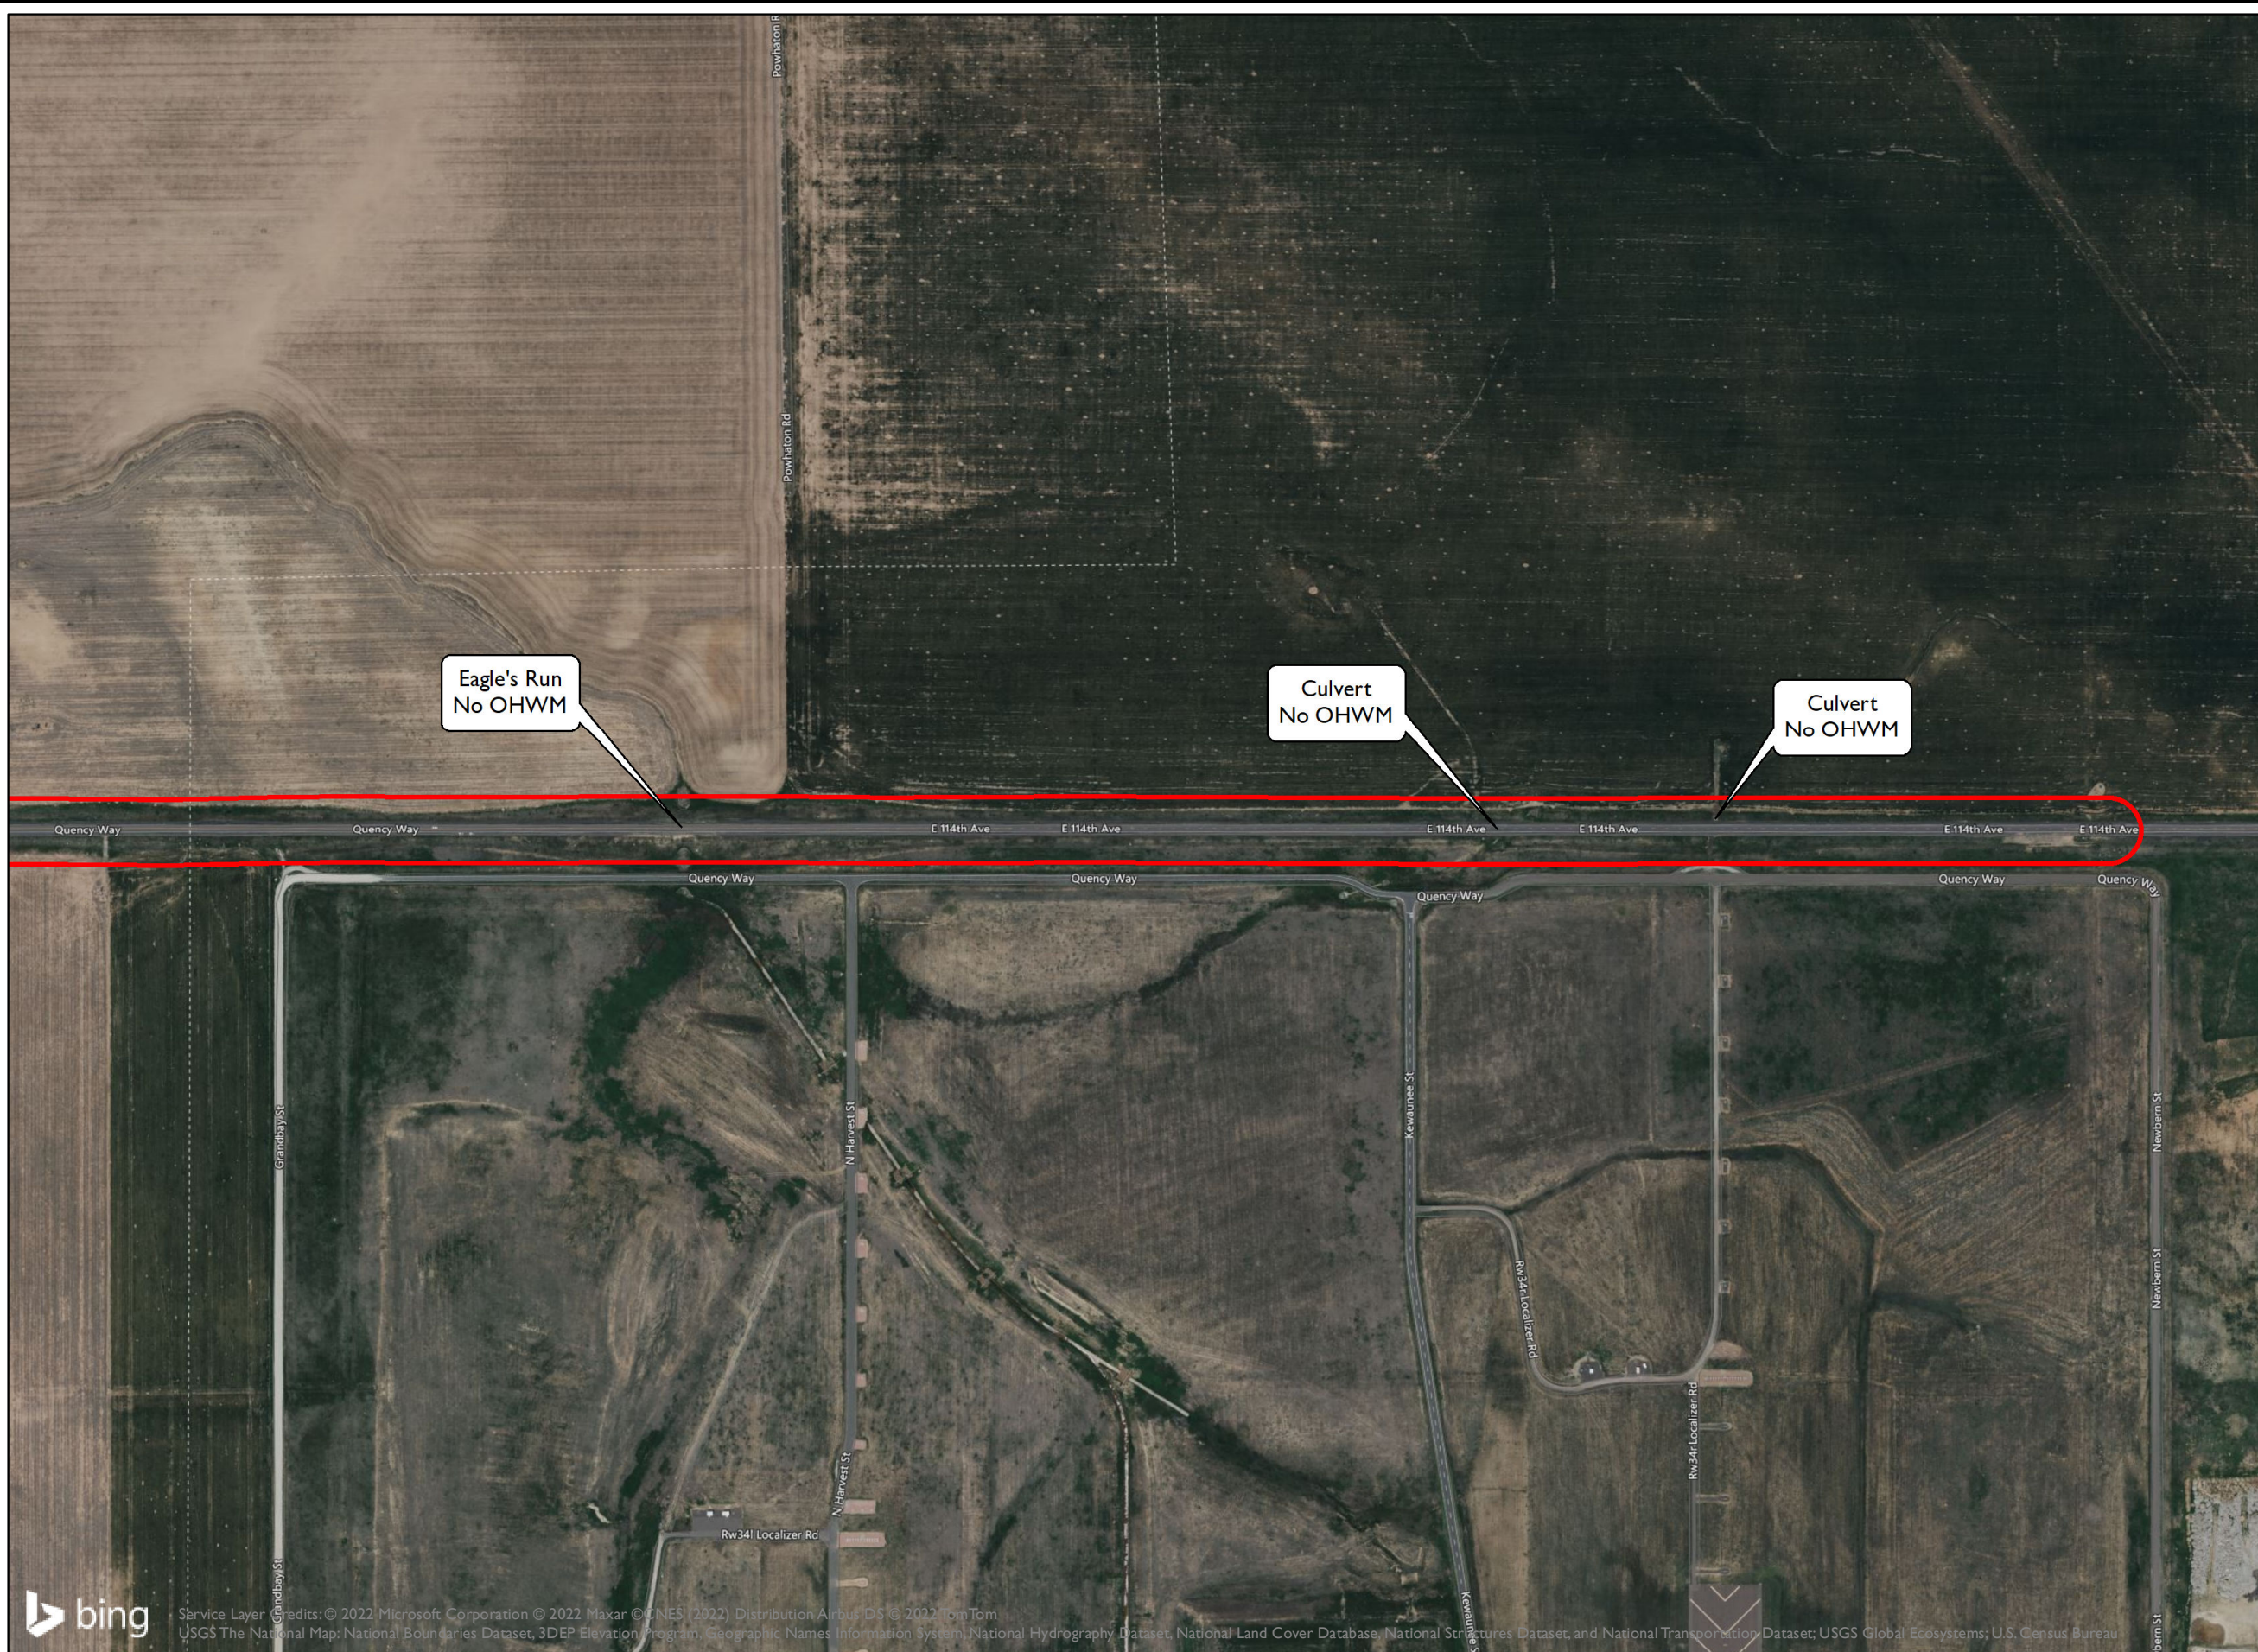
Drawn By: MJS	Figure: 2; page 1 of 5
Reviewed By: BB	Date: 11/16/2022

Eagle's Run, and two unnamed ditches are located in the northeastern section of the study area (Figure 2, page 1 and 2). These features are visible via aerial imagery, topographic imagery, and the NWI (Google Earth, 2022; USFWS, 2022). Eagle's Run and the two unnamed ditches both extend under East 114th Avenue within the study area. No OHWM and no open water were identified for these features within the study area during the site visit.

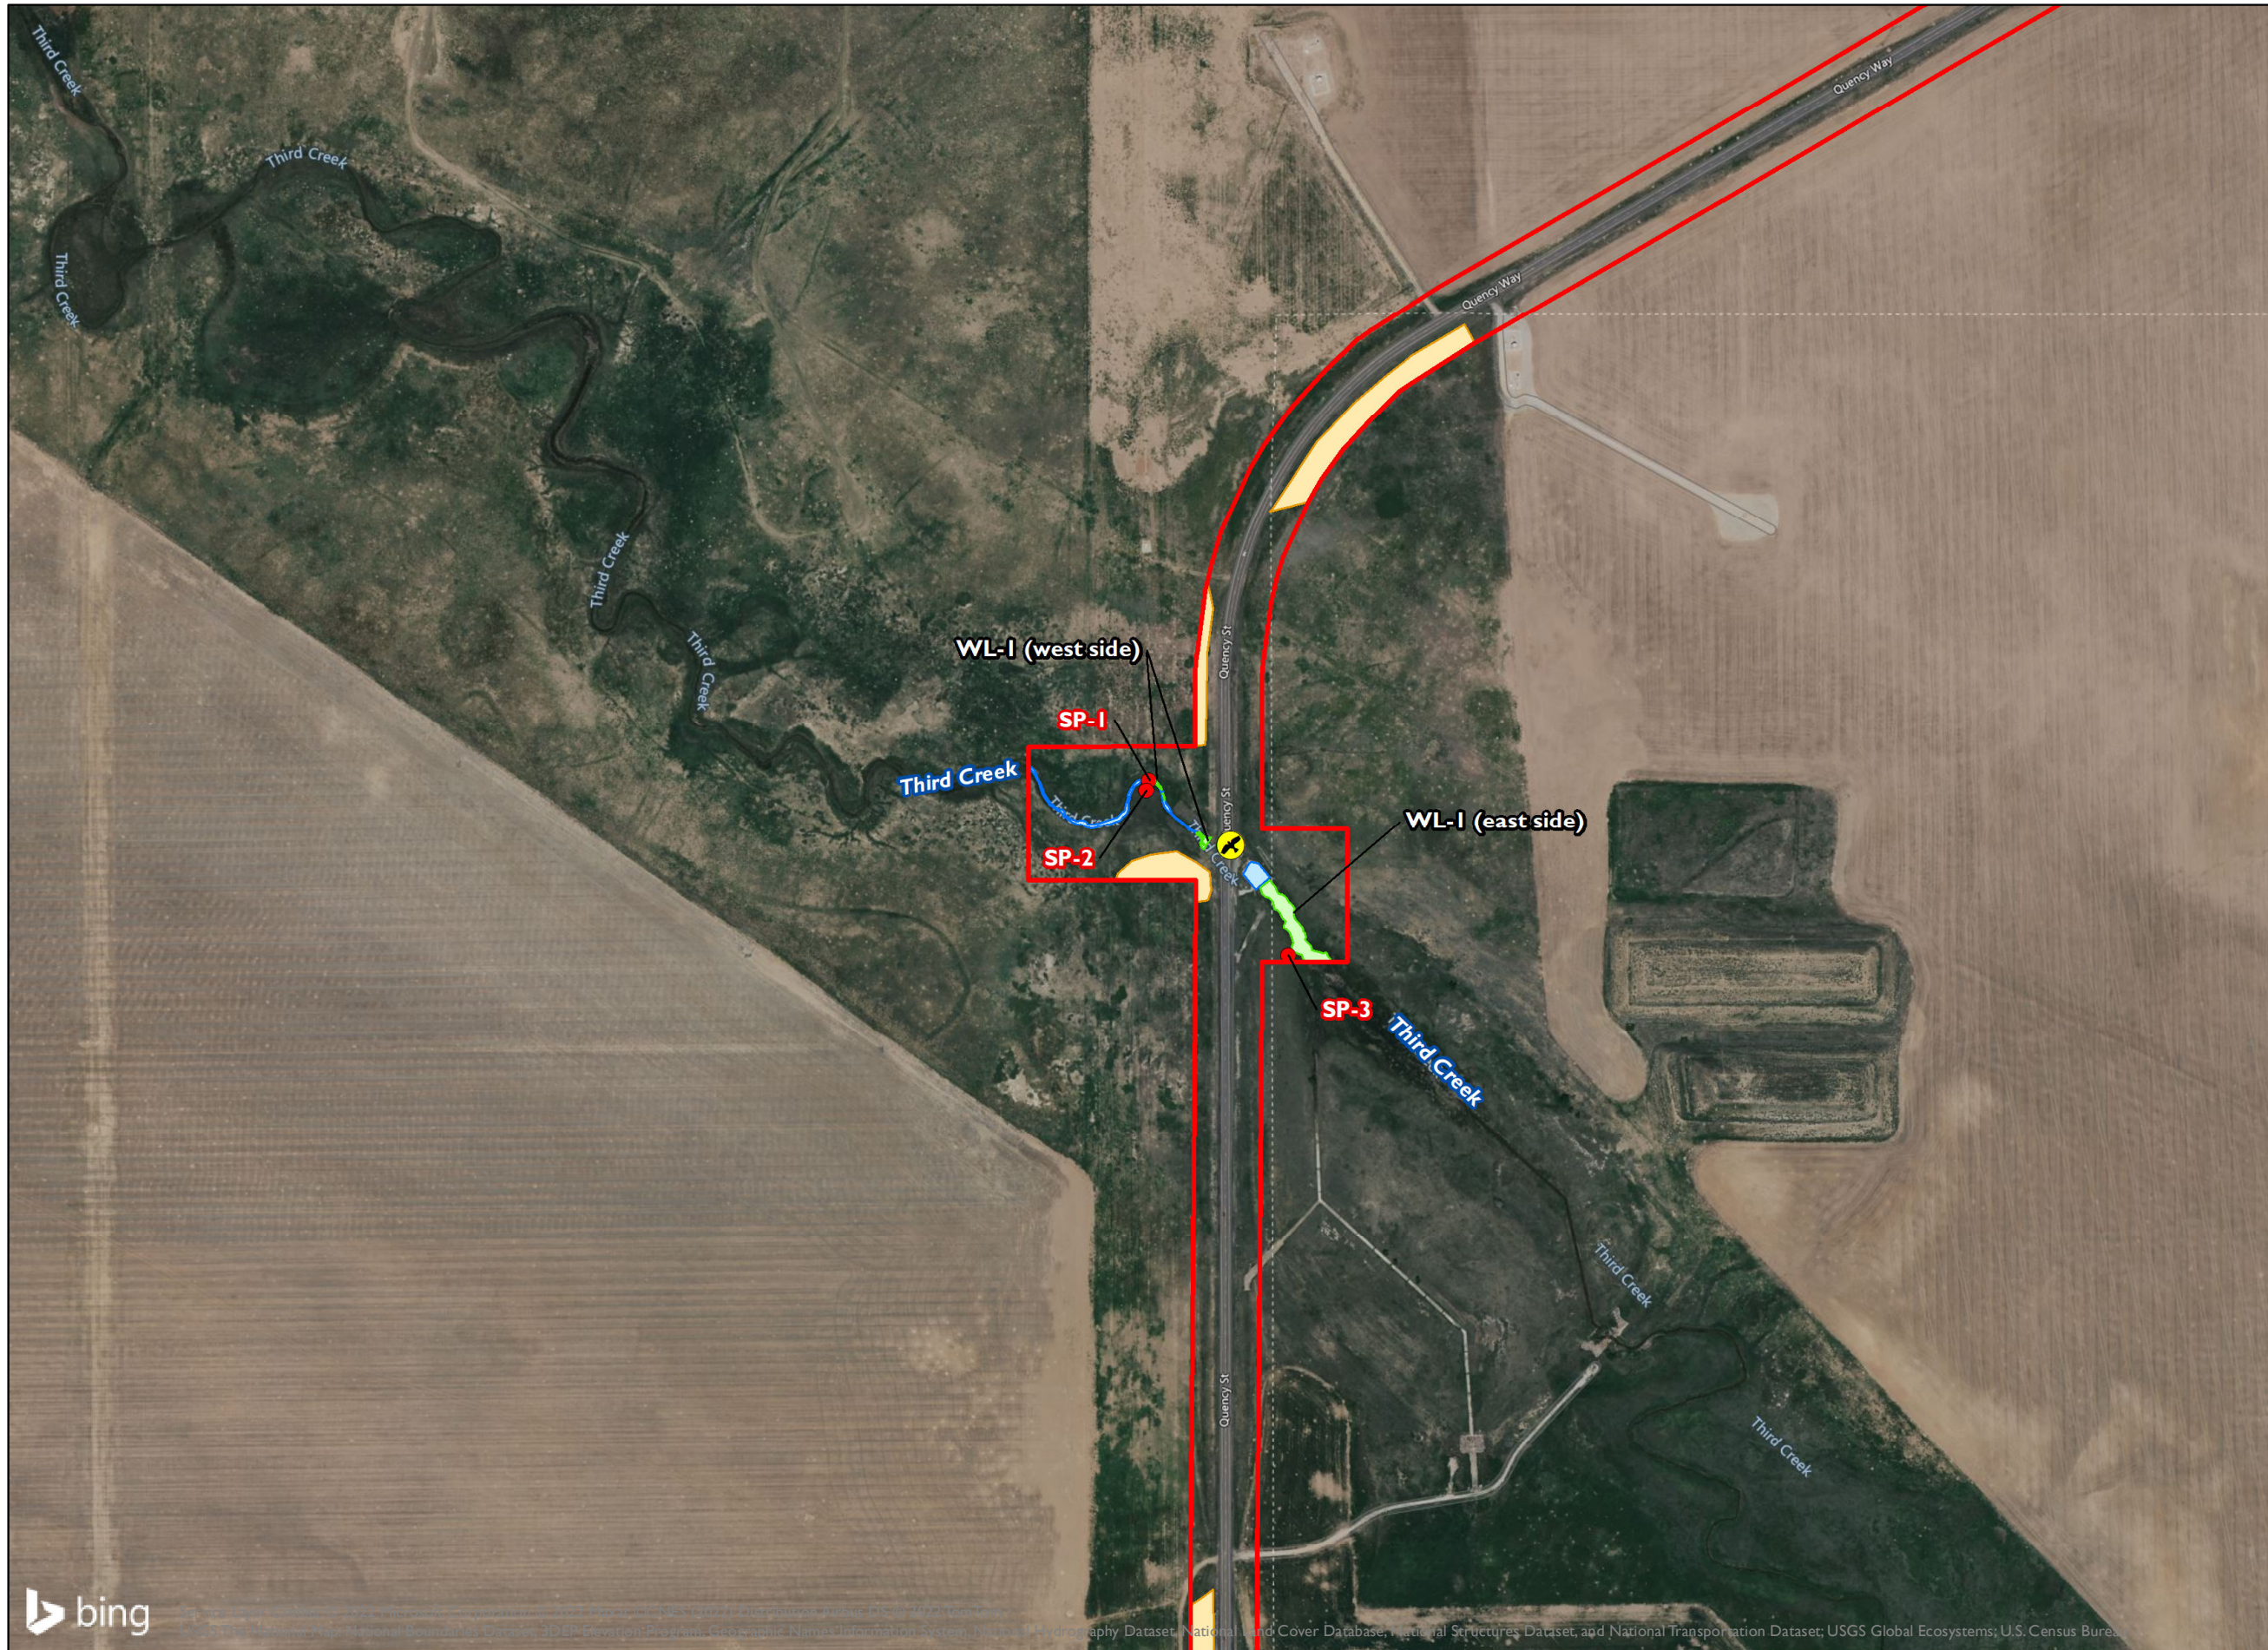
Drawn By: MJS Figure: 2; page 3 of 5

Third Creek and its associated wetland (WL-1) were mapped within the study area on both the east and west sides of West Cargo Road (Figure 2, page 3; Photos 4-6 in Photographic Log; Appendix A). Third Creek is a perennial stream, with a defined OHWM, that flows toward the northwest through the study area, ultimately

-   Study Area
-   Sampling Point
-   Cliff Swallow Nests
-   Wetlands
-   Non-Wetland Waters
-   Black-tailed Prairie Dog Area

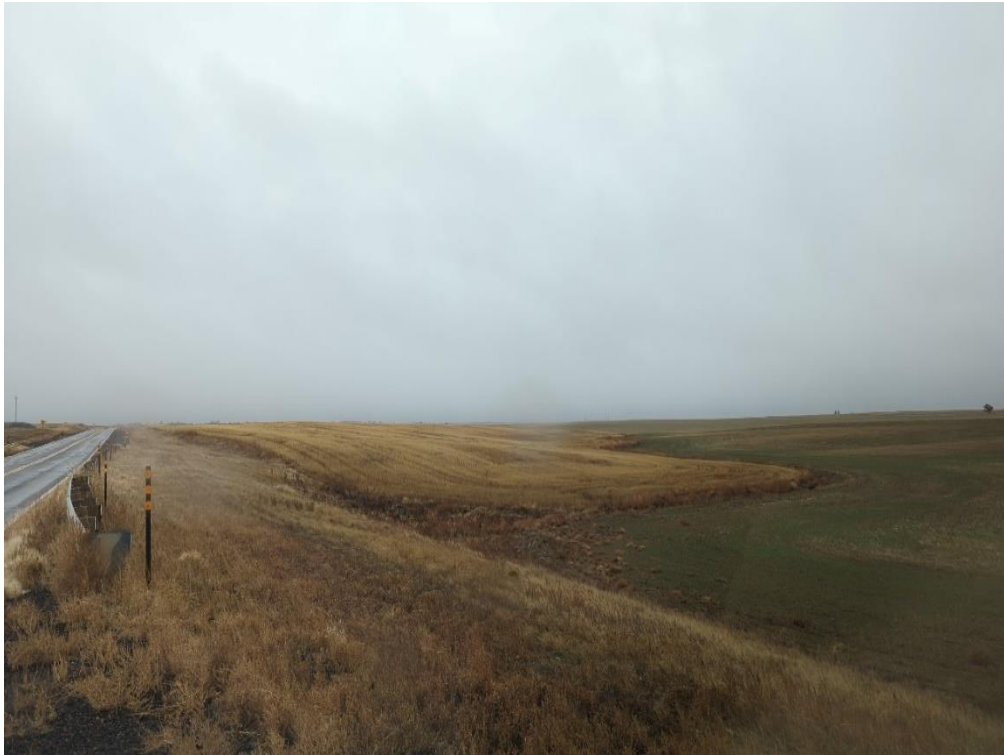
Photo 1. The study area included both sides of mowed Right-of-Way (ROW) bordered by agricultural fields. Photo taken facing east.

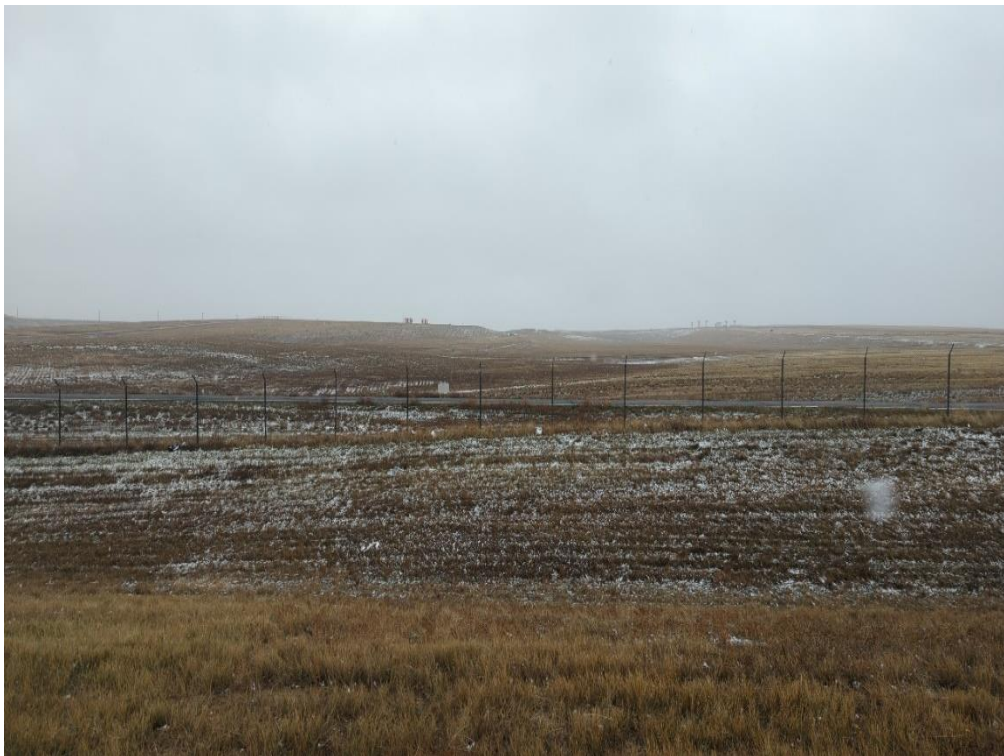
Photo 2. Facing south towards the Denver International Airport property border at the north end of the study area.

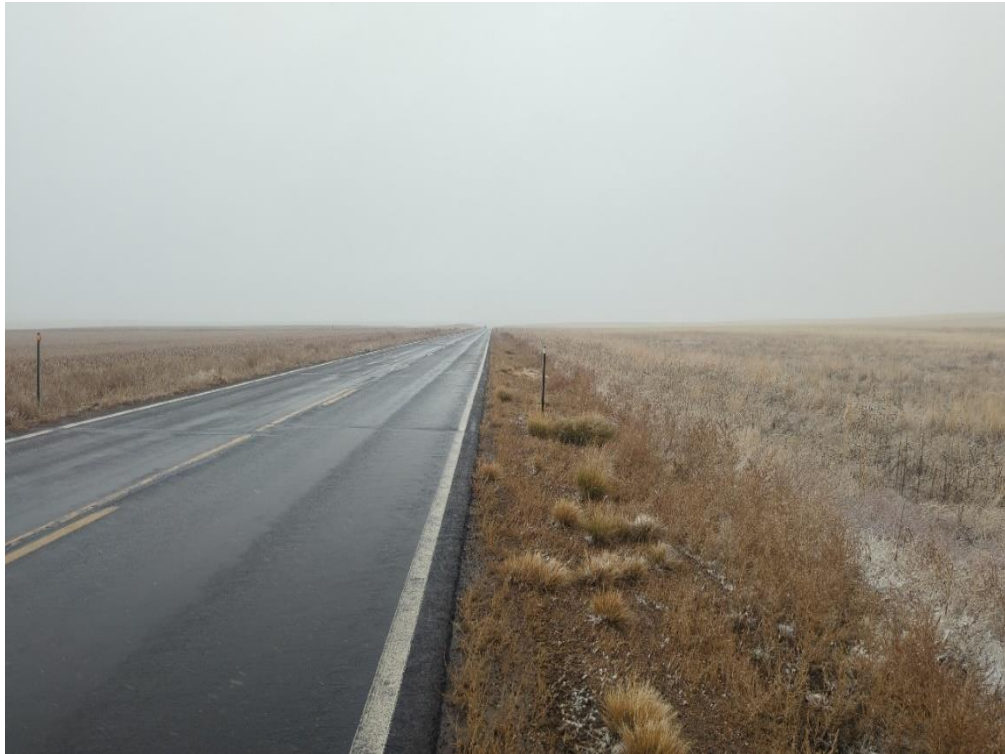
Photo 3.
General
vegetation in the
study area
includes sand
dropseed
(*Sporobolus
cryptandrus*),
annual sunflower
(*Helianthus
annuus*), Russian
thistle (*Salsola
tragus*), and
smooth brome
(*Bromus
tectorum*). Photo
taken in the
southern portion
of the study
area, facing east.

species such as sand dropseed (*Sporobolus cryptandrus*), smooth brome (*Bromus inermis*), prickly lettuce (*Lactuca serriola*), and kochia (*Bassia scoparia*) (Photo 3 in Photographic Log). Scattered cottonwood (*Populus deltoides*) and Russian olive (*Elaeagnus angustifolia*) trees were also noted.

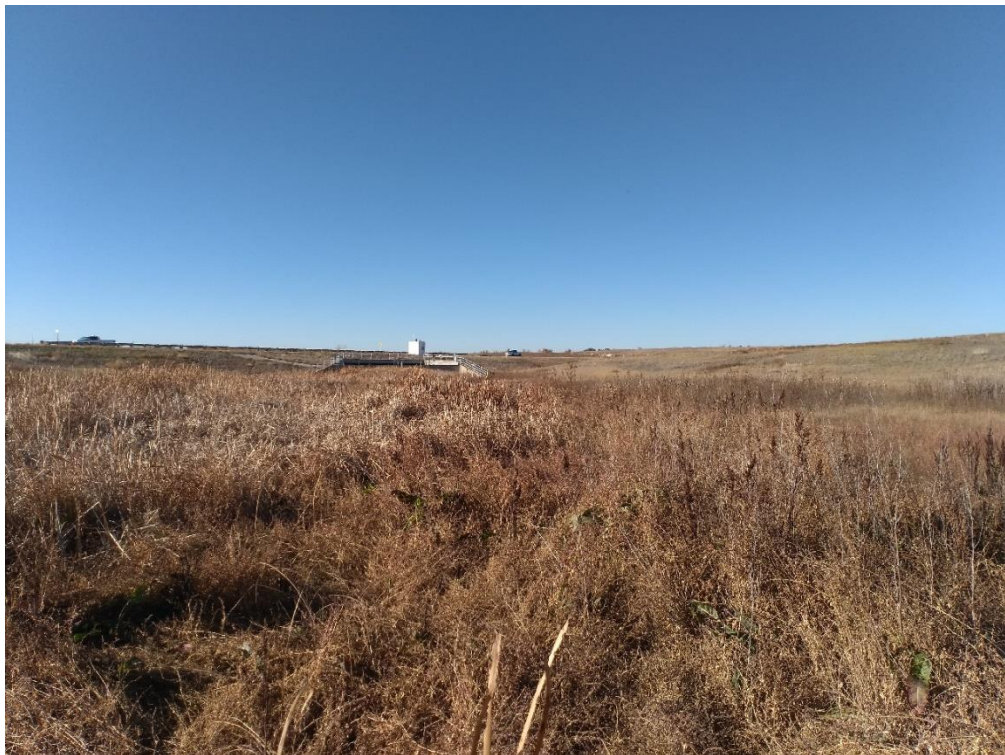
Photo 4.
Wetland I (WL-
I) east of West
Cargo Road
along Third
Creek. Photo
taken facing
west.

One wetland system, Wetland 1 (WL-1), located along Third Creek, was mapped within the study area, and is discussed further below (Figure 2, Photos 4-6 in Photographic Log, Appendix A).

WL-1 was observed to be a palustrine emergent (PEM) wetland dominated in the herbaceous stratum by narrowleaf cattail (*Typhus angustifolia*), an obligate wetland species. Other common herbaceous plants associated with WL-1 included softstem bulrush (*Schoenoplectus tabernaemontanii*), an obligate wetland species. The wetland hydric soil indicator observed was Hydrogen Sulfide (A4). The hydrology indicators observed were Surface Water (A1), High Water Table (A2), Saturation (A3), and Hydrogen Sulfide Odor (C1). Sampling Point 1 (SP-1) was completed in WL-1 (Appendix A). Sampling Points 2 and 3 (SP-2 and SP-3) were upland pits dug west and east of West Cargo Road, respectively (Appendix A).

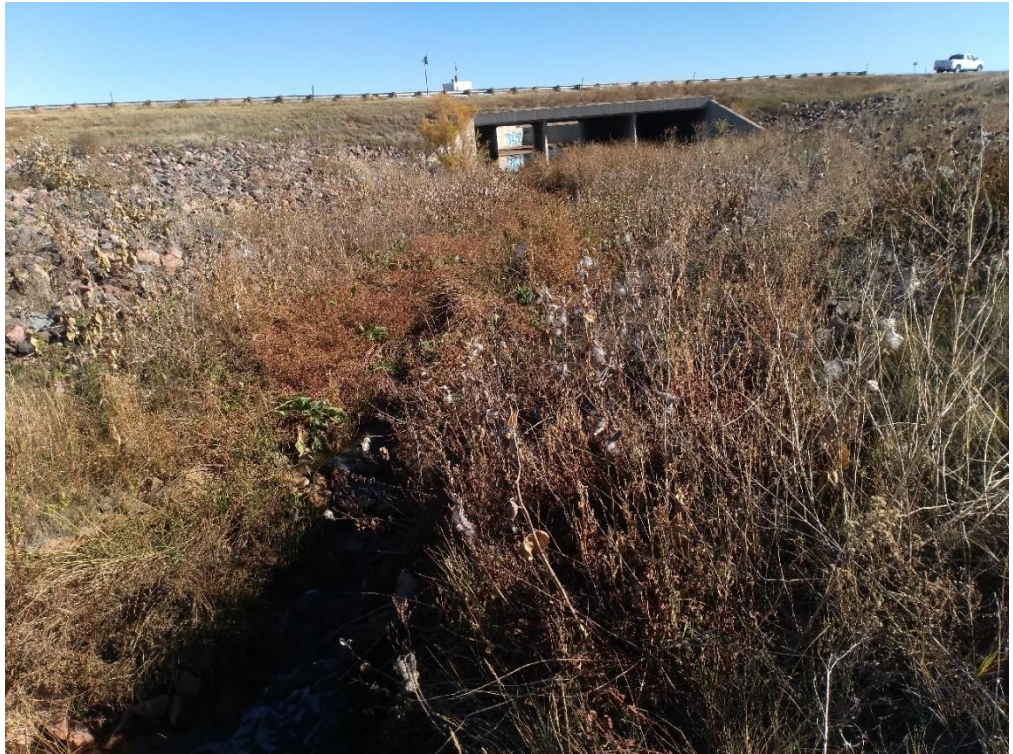
Photo 5. WL-1
west of West
Cargo Road
along Third
Creek, facing
east.

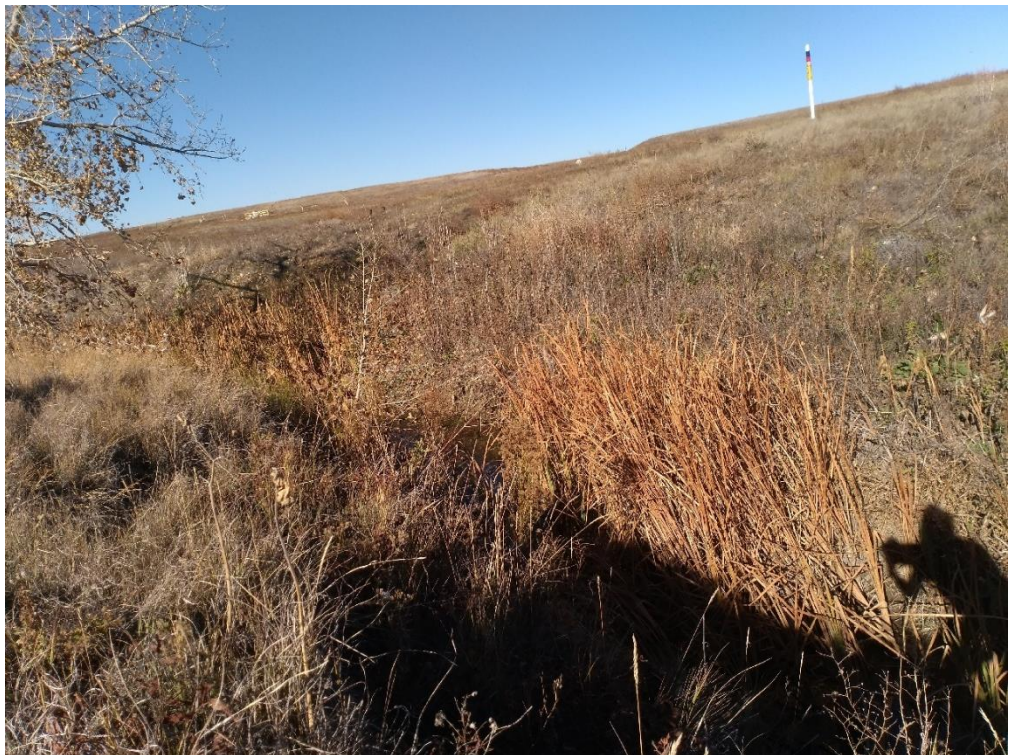
Photo 6. WL-1
west of West
Cargo Road
along Third
Creek, facing
northwest.
Sampling Points
1 and 2 taken
nearby.
