## Biological Resource Technical Memorandum

**Date:** November 15, 2022  
**To:** Craig Lamacraft, Denver Water  
**From:** Becky Burink, Biologist, Pinyon Environmental, Inc.  
**Subject:** Denver International Airport/E-470 Pipeline Project

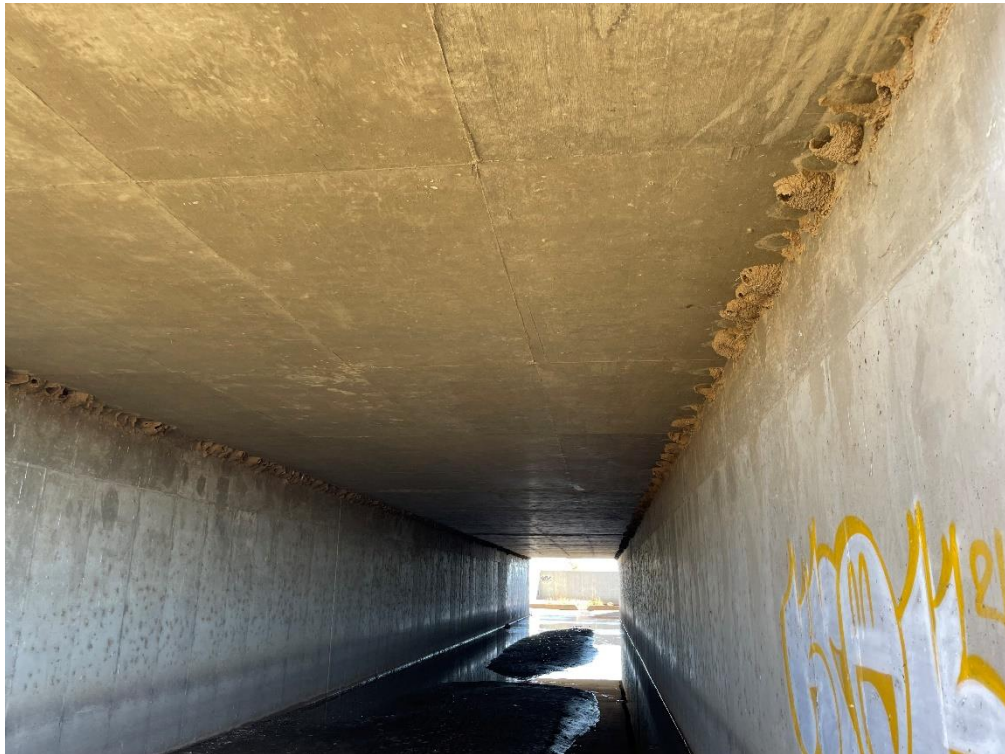
Non-raptor migratory bird nests, namely Cliff Swallow (*Petrochelidon pyrrhonota*) nests, were observed lining concrete box culverts within the study area (Photo 8 in Photographic Log). Like raptors, Cliff Swallows are protected by the MBTA.

Photo 8. Cliff Swallow (*Petrochelidon pyrrhonota*) nests lined the box culvert along Third Creek. Photo taken in west entrance to culvert, facing east.

If construction activity is planned to take place during the migratory bird nesting season, and within 50 feet of active nests (e.g. the Third Creek culvert), Pinyon recommends removal of Cliff Swallow nests prior to construction, and prior to bird nesting activities, and continued monitoring and removal of inactive nests from these culverts throughout construction – this can be in accordance with the above-cited 240 specification. If nests are found to be active, construction activity within 50 feet of the active nests should cease until nesting activities are completed, to avoid incidental take of protected Swallows. Note that Cliff Swallow nesting activities may take several weeks to months, depending on the number of swallows that are able to lay eggs. Alternatively, should construction activity take place outside of the migratory bird nesting season (between September 1 and March 31), then no further action regarding migratory birds is needed.
