Biological Resource Technical Memorandum

Date: November 15, 2022
To: Craig Lamacraft, Denver Water
From: Becky Burink, Biologist, Pinyon Environmental, Inc.
Subject: Denver International Airport/E-470 Pipeline Project

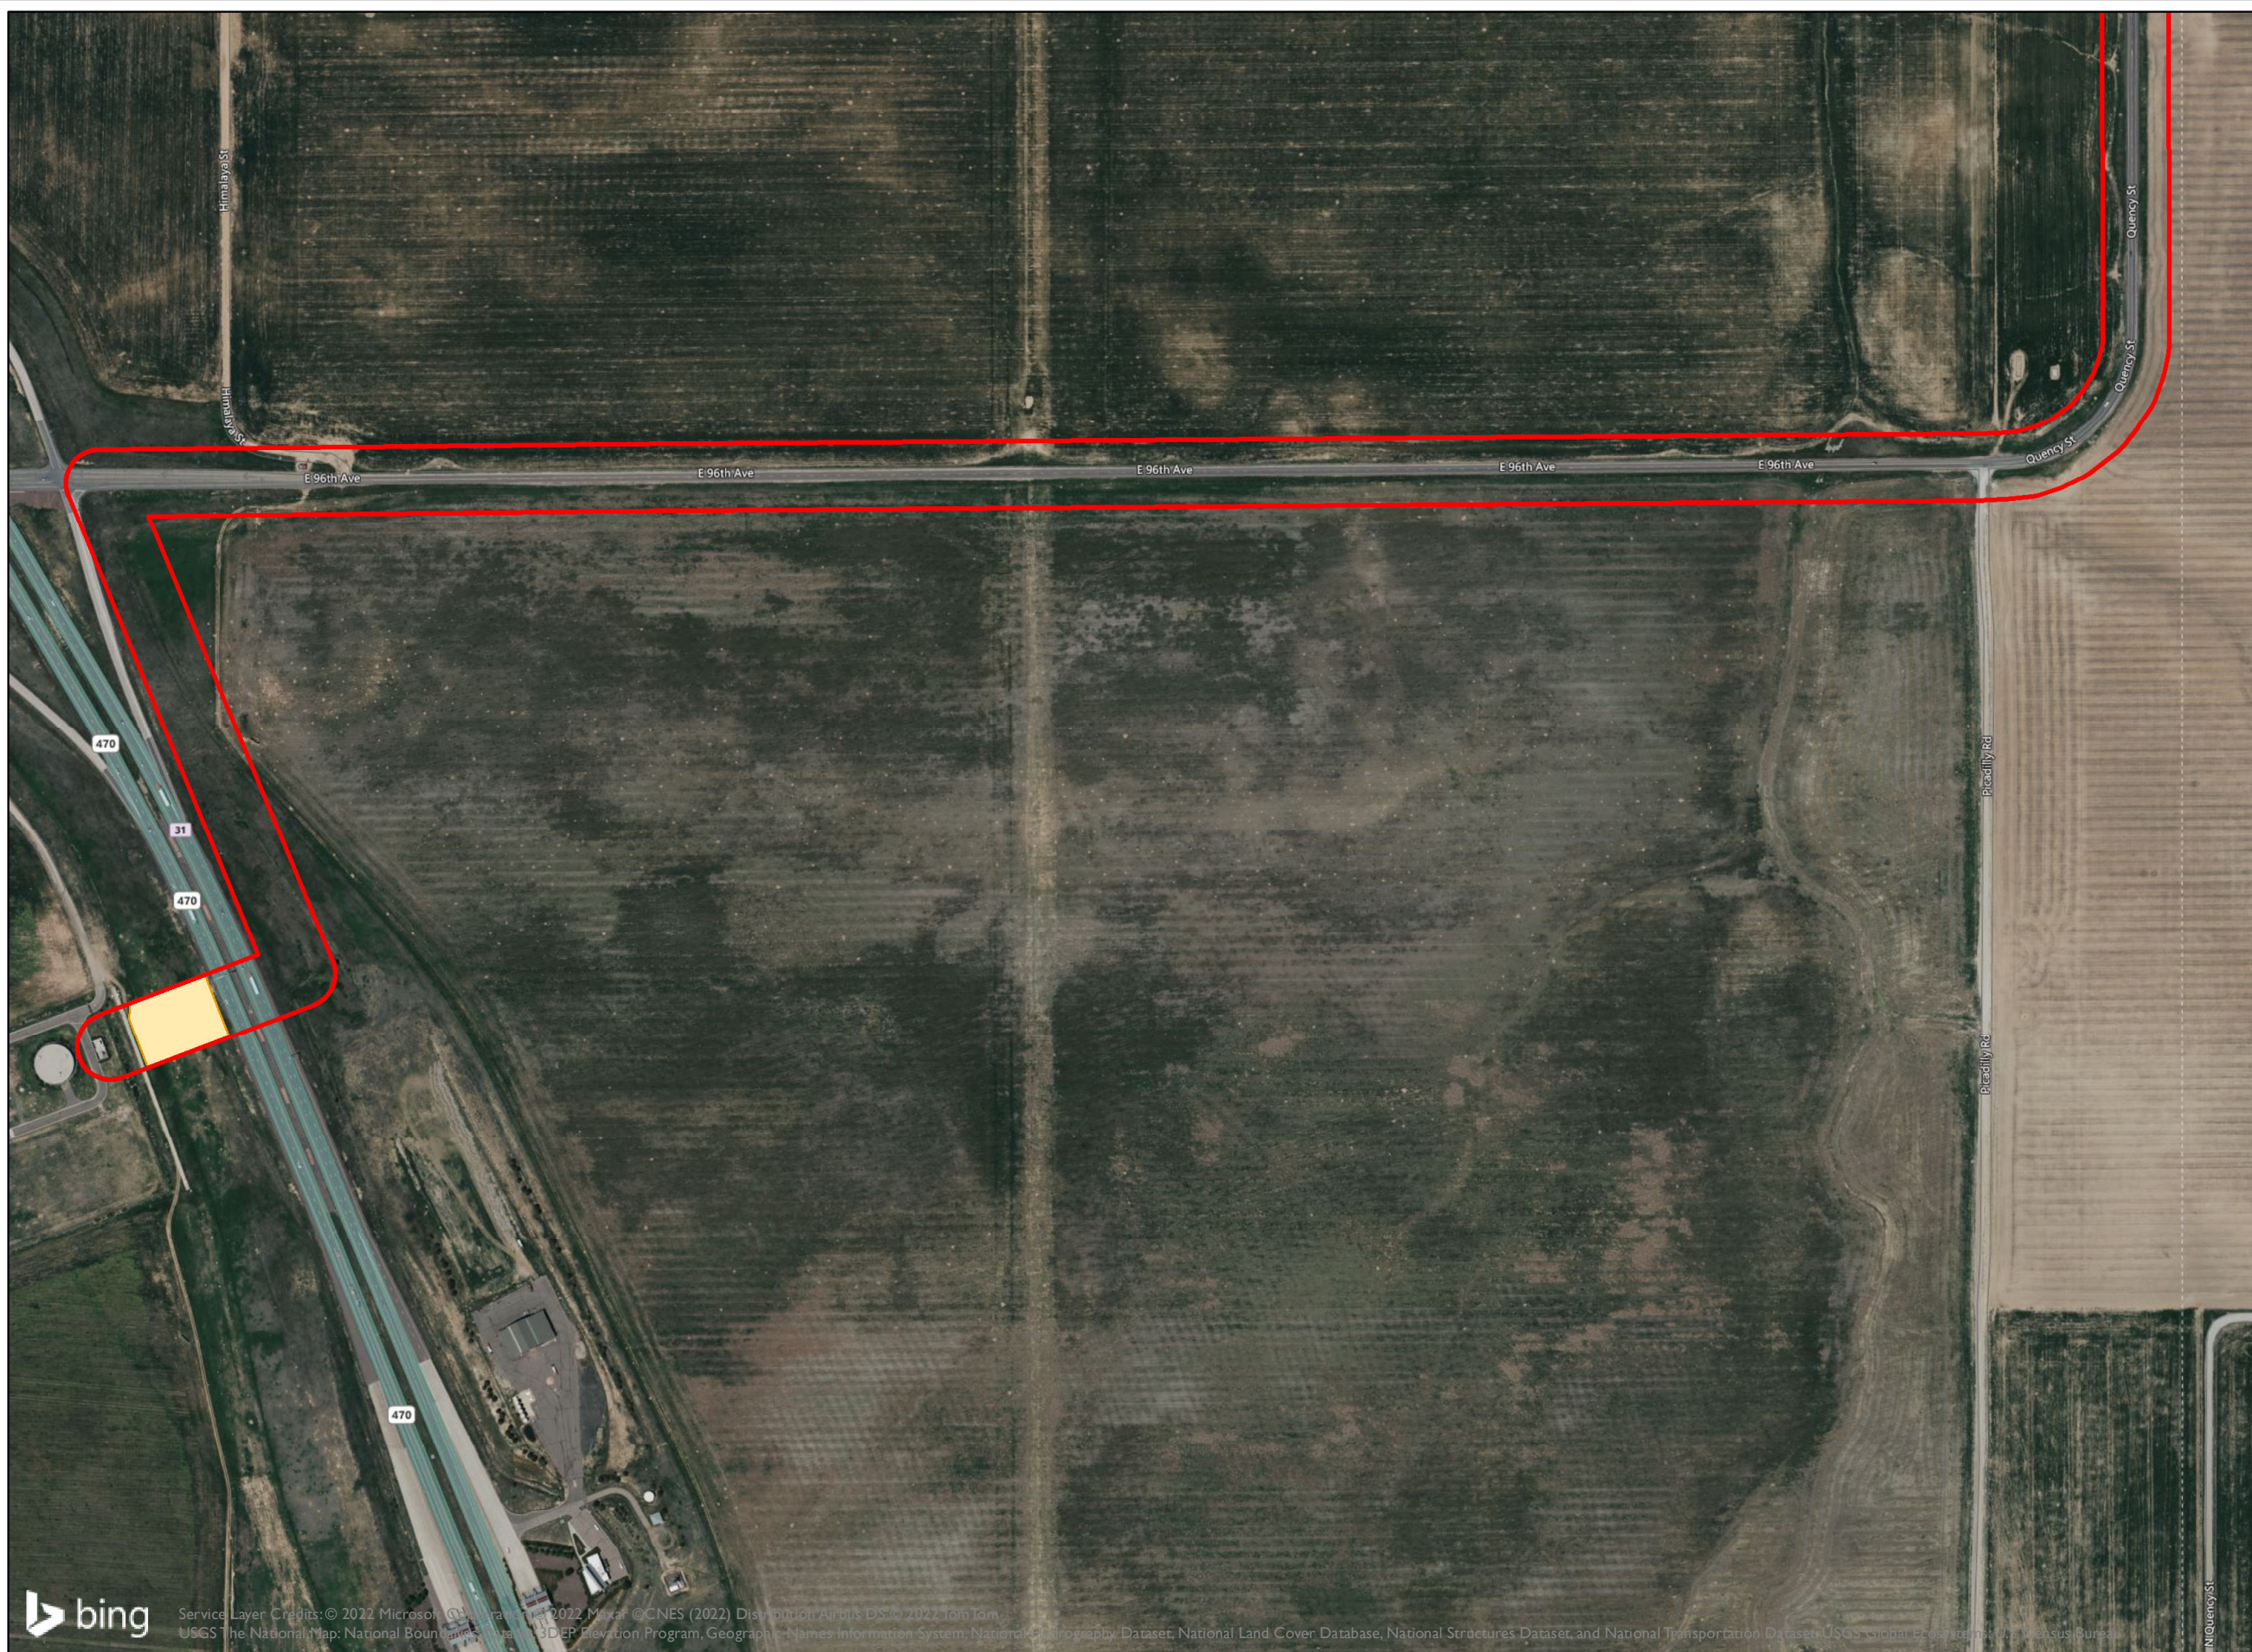
Drawn By: MJS	Figure: 2; page 5 of 5
Reviewed By: BB	Date: 11/16/2022

Black-tailed Prairie Dog Area

Black-tailed prairie dog burrows are present in the study area, which provide suitable nesting habitat for Burrowing Owls. With regards to prairie dogs, it is likely that the prairie dogs can be humanly “passively relocated” from the proposed work areas prior to construction.
