**SECOND CREEK RESTORATION  
ECOLOGICAL RESOURCES REPORT  
COMMERCE CITY, COLORADO**

August 9, 2019

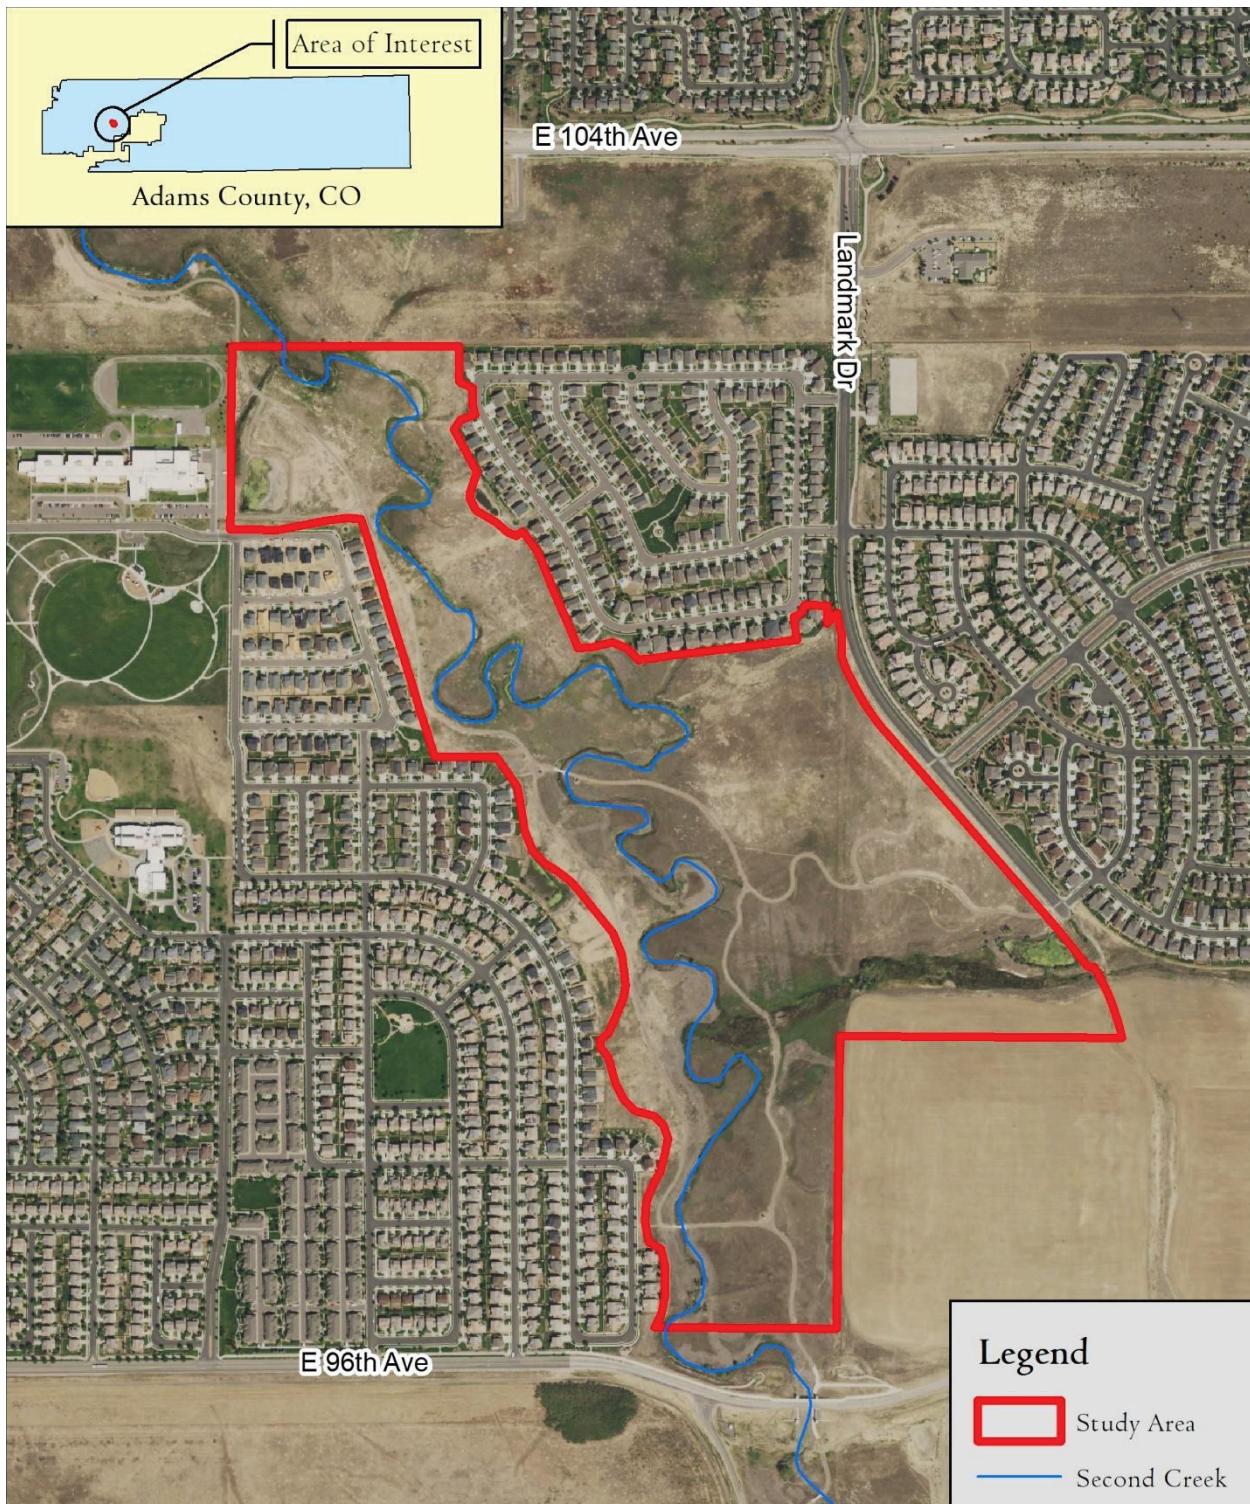
Figure 1  
Study Area  
Adams County, Colorado  
July 2019

The Study Area (Figure 1) is located adjacent to Second Creek between E 104th Avenue and E 96th Avenue in Sections 16 and 17, Township 2 South, Range 66 West of the 6th Principal Meridian on the Brighton US Geological Survey (USGS) quadrangle. The center of the Study Area is located at 39.879197 degrees north, 104.795585 degrees west at an elevation of approximately 5,150 feet. The Study Area is managed as a City-owned open space property. Land use to the east and west is primarily residential. The Rocky Mountain Arsenal National Wildlife Refuge is located south of E 96th Avenue. Other surrounding lands are either vacant or are in agricultural production; however, most are zoned as Planned Urban Development (PUD) and will likely be developed in the future.

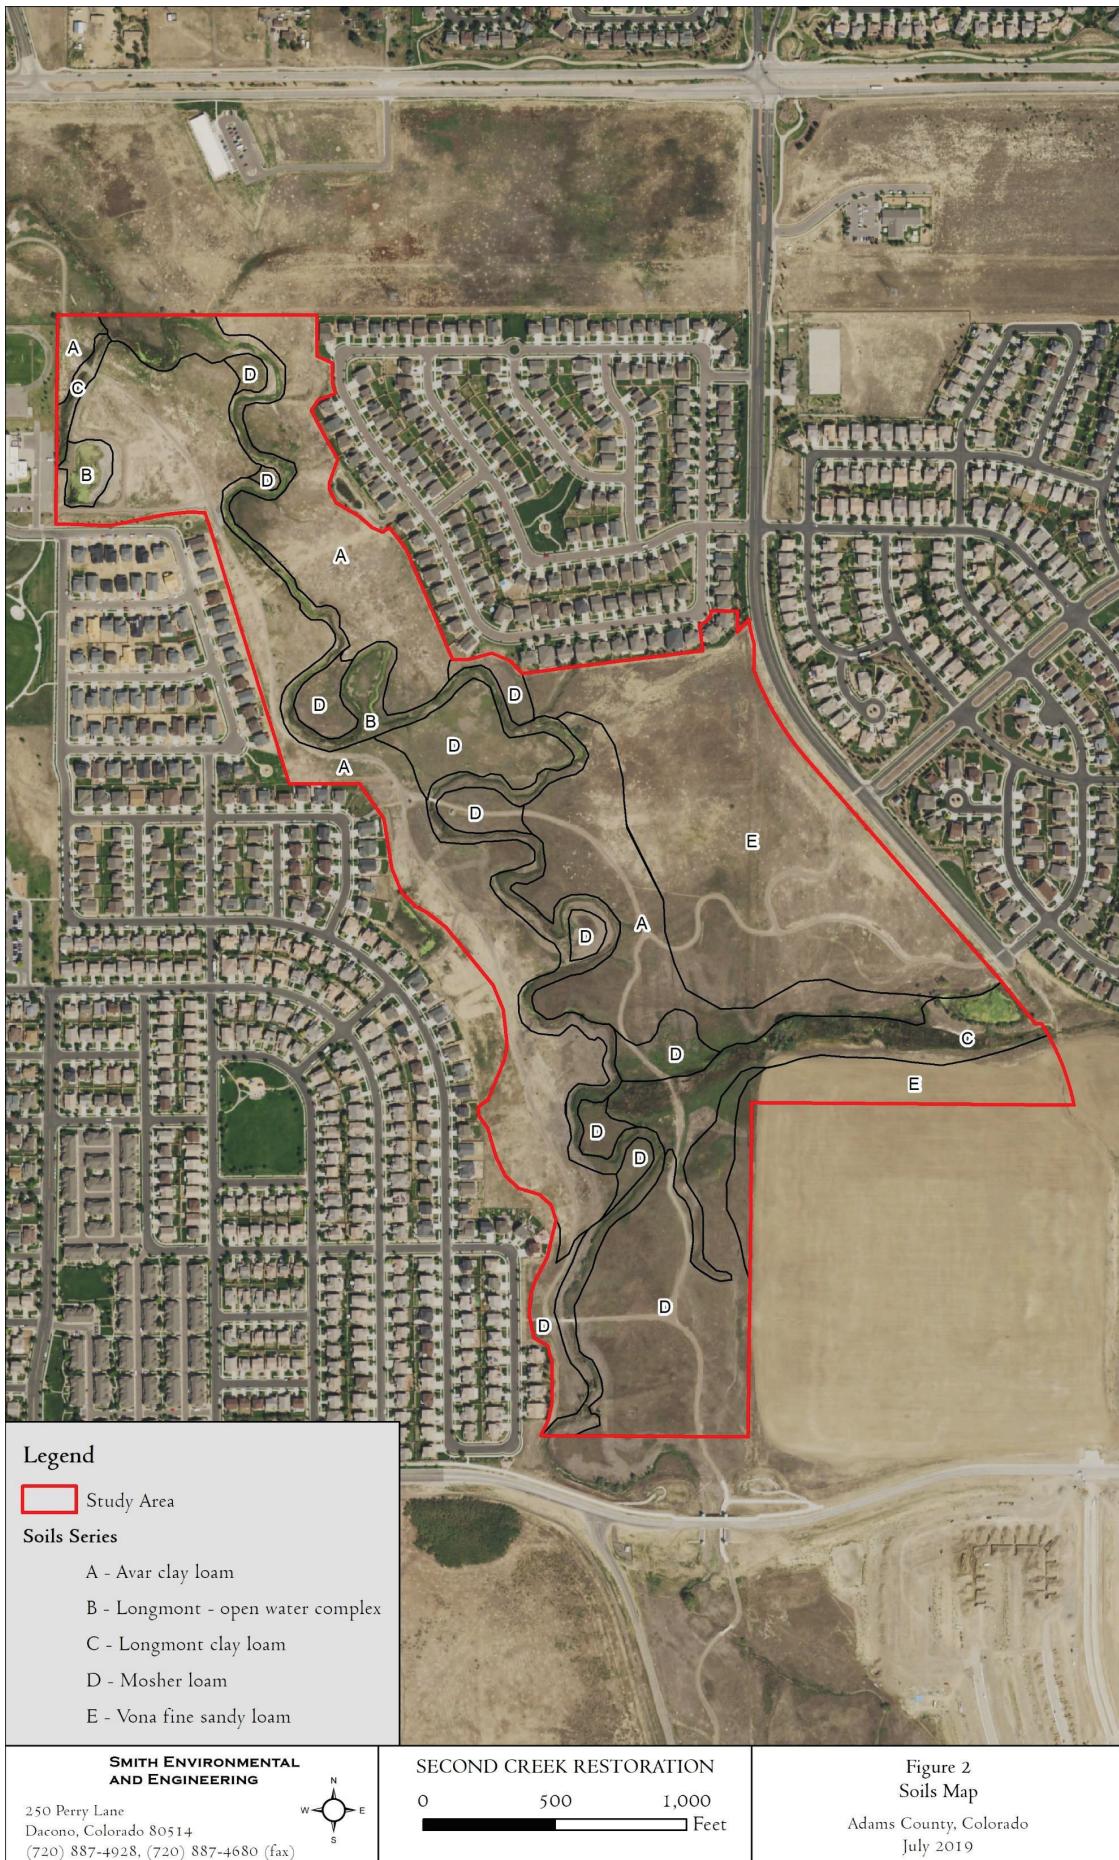
Four soil series were identified in the Study Area: Vona, Avar, Mosher, and Longmont (Figure 2). Vona and Avar soils are well-drained, deep, and medium to coarse textured. Mosher is moderately well-drained to somewhat poorly drained and fine textured. A medium-textured version of Mosher was observed during mapping but was included with the delineations of Mosher. Longmont soils are poorly drained and fine textured. Avar, Longmont, and Mosher are most common in the Study Area and are saline and sodic. Vona is neither saline nor sodic. In the Vona and Avar soils, depth to the water table is typically greater than 40 in. below ground surface during the growing season. In the Mosher soil, the water table is typically 25 to 50 in. below ground surface, and in the Longmont soil it is typically less than 20 in. below ground surface. Mosher and Longmont soils support the Salt Meadow Ecological Site, Avar soils support the Salt Flat Ecological Site, and Vona soils support the Sandy Plains Ecological Site (NRCS 2011).

The water table is less than 6 ft below ground surface across most of the Study Area, and occasionally high sodium water ascends in the soil profile through capillary rise during high-water table events. Before the reclamation of sodic soil can be undertaken in the Study Area, a drain system would need to be installed to keep the water table at or below 5 ft. Mosher, Longmont and Avar soils are all sodic within the Study Area. Because the installation of a drain system is not feasible in areas where the water table is high (less than 40 in.), reclamation of Longmont soil areas is not feasible. It is recommended sodic soil reclamation be attempted only in Avar and Mosher soils.

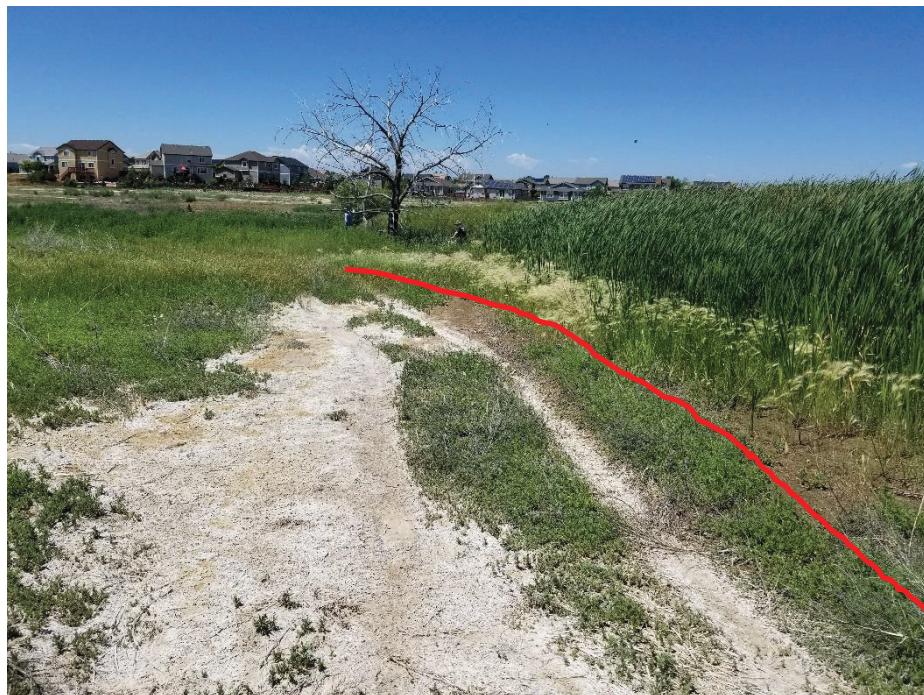
The wetland and riparian vegetation that occurs along Second Creek, a detention pond, and a stormwater drainage constitute a second unit (Photos 1 and 2). Some of the species observed are included in Table 1, specifically in the Aquatic Plants section. SMITH understands that the City will be focusing restoration efforts on the upland areas within the Study Area. There are opportunities for restoration along this riparian corridor, but continued development within the watershed will lead to changes in the hydrologic regime of Second Creek. A long-term, sustainable restoration effort in this area will be more successful when development within the local area has largely ceased.

**Photo 2.** View looking west along a wetland drainage dominated by cattails. Salt crusting is evident in the Mosher soils (left of the red line). Longmont soils occur in the wetland area (right of the red line).

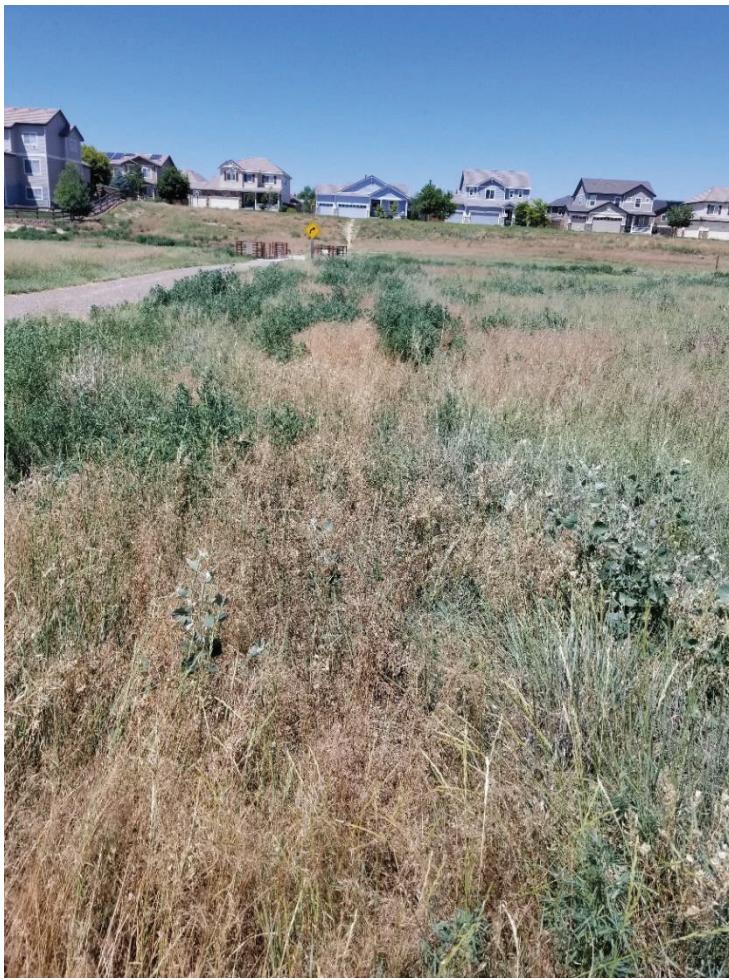
**Photo 3.** View looking west at an area with Avar soils supporting some native grasses but also an abundance of weeds. The dark green plant is kochia, and the lighter green forb in the foreground is lambsquarters.

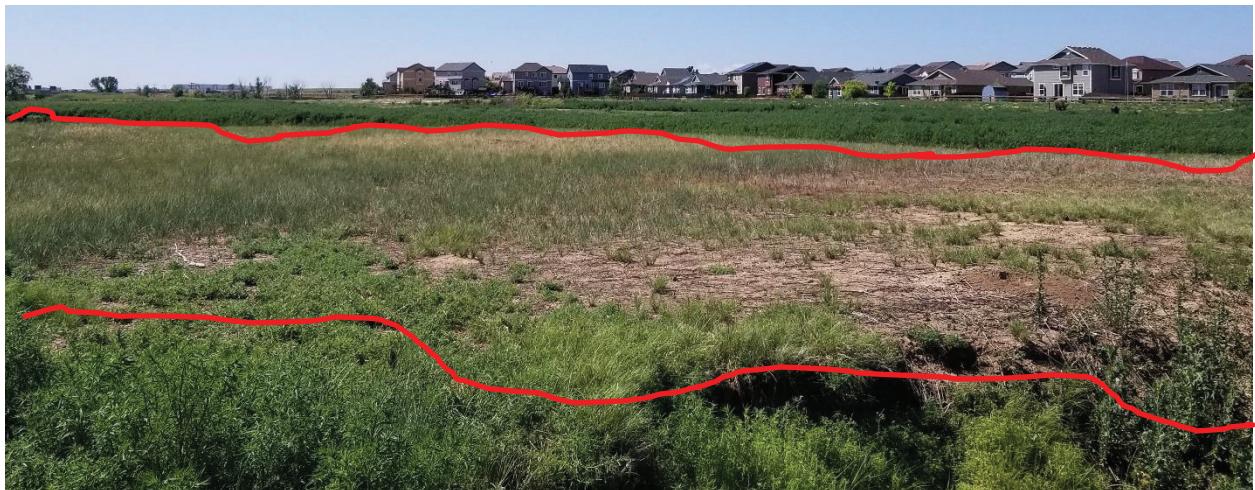
**Photo 4.** View looking southwest towards an area of Avar (central area) and Mosher soils (foreground and background). These areas have a mix of native grasses and weeds. The dark vegetation in the background is kochia.

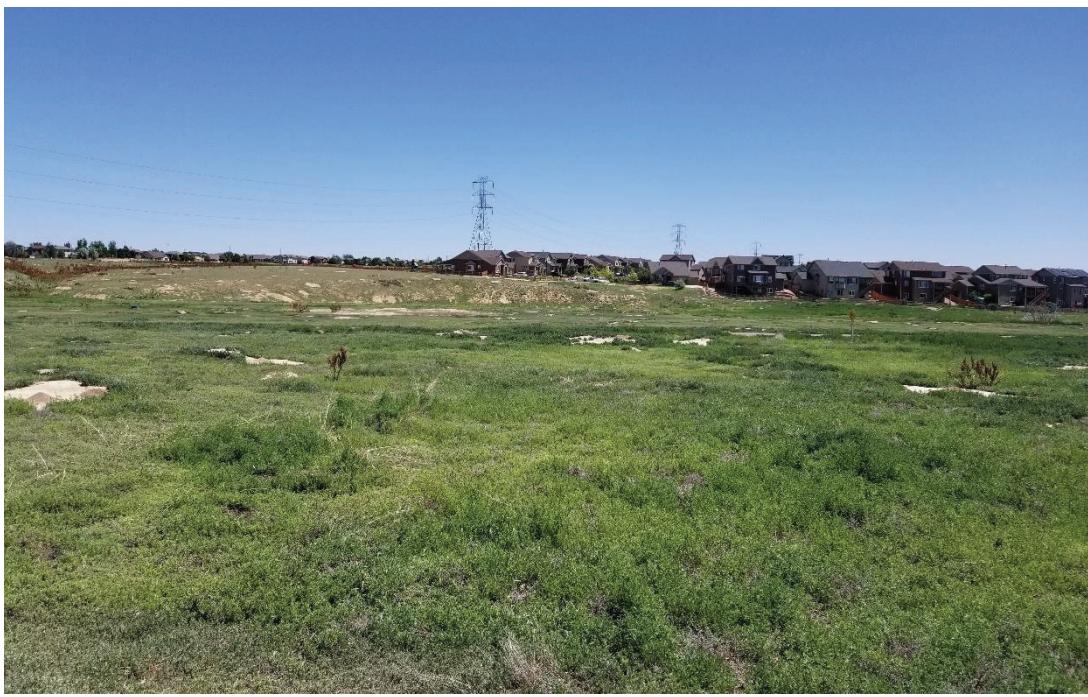
**Photo 5.** View looking east from near Stuart Middle School across an area with Avar soils and dominated by kochia.

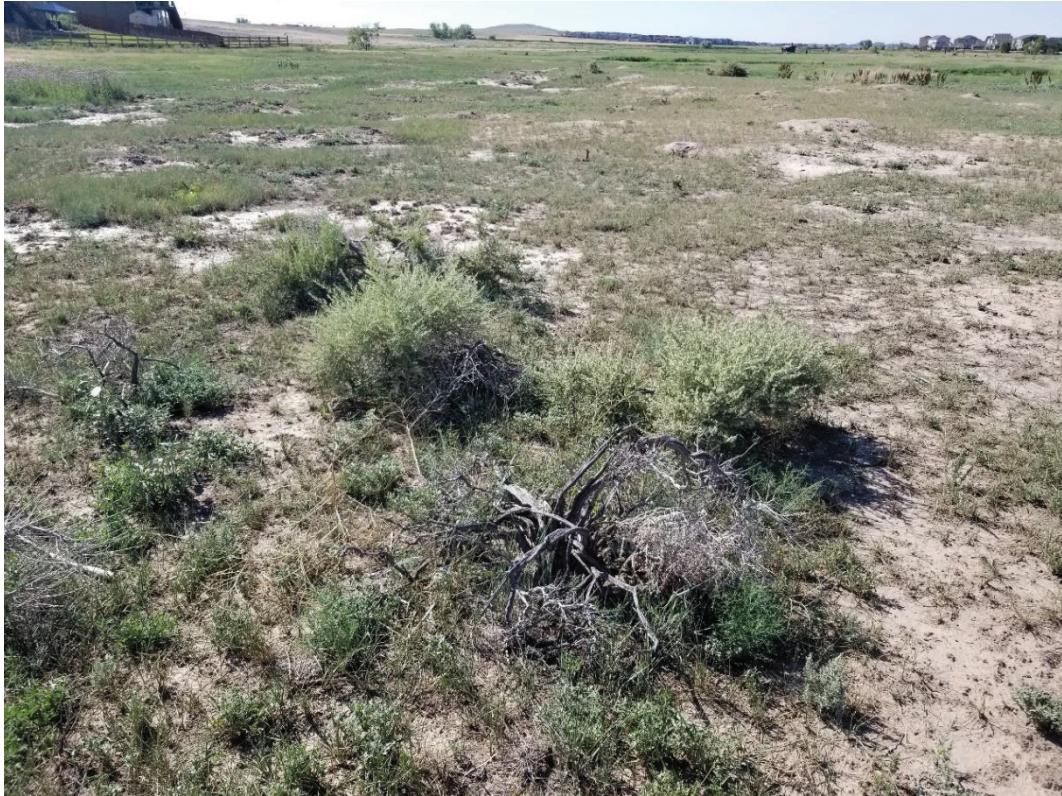
The final vegetative unit described is labeled Dominant Weeds and/or Exposed Soils in Figure 3 (in orange). These areas do vary in species composition and overall cover, but they are generally characterized by high levels of disturbance and a drastic deviation from historical conditions. Prairie dog activity is common in nearly all of these areas, and in some areas, there is also evidence of surface disturbance activities. The area east of Stuart Middle School is dominated by kochia, which is a nonnative, weedy species (Photo 5). There is little bare ground, but there are also few desirable species, including grasses. The areas farther south and adjacent to Second Creek have more grasses and native species present, including alkali sacaton, western wheatgrass, inland saltgrass, fourwing saltbush, Rocky Mountain beeplant (*Cleome serrulata*), and cutleaf nightshade (*Solanum triflorum*). However, these species are intermittent, and there are large patches of bare ground with salt deposits at the surface (Photos 6 and 7).

**Photo 6.** View looking south in an area east of Second Creek with Avar soils, intermittent native grasses (mostly inland saltgrass), and fourwing saltbush (shown above). Prairie dogs are present in this area, and there is a significant amount of bare ground.

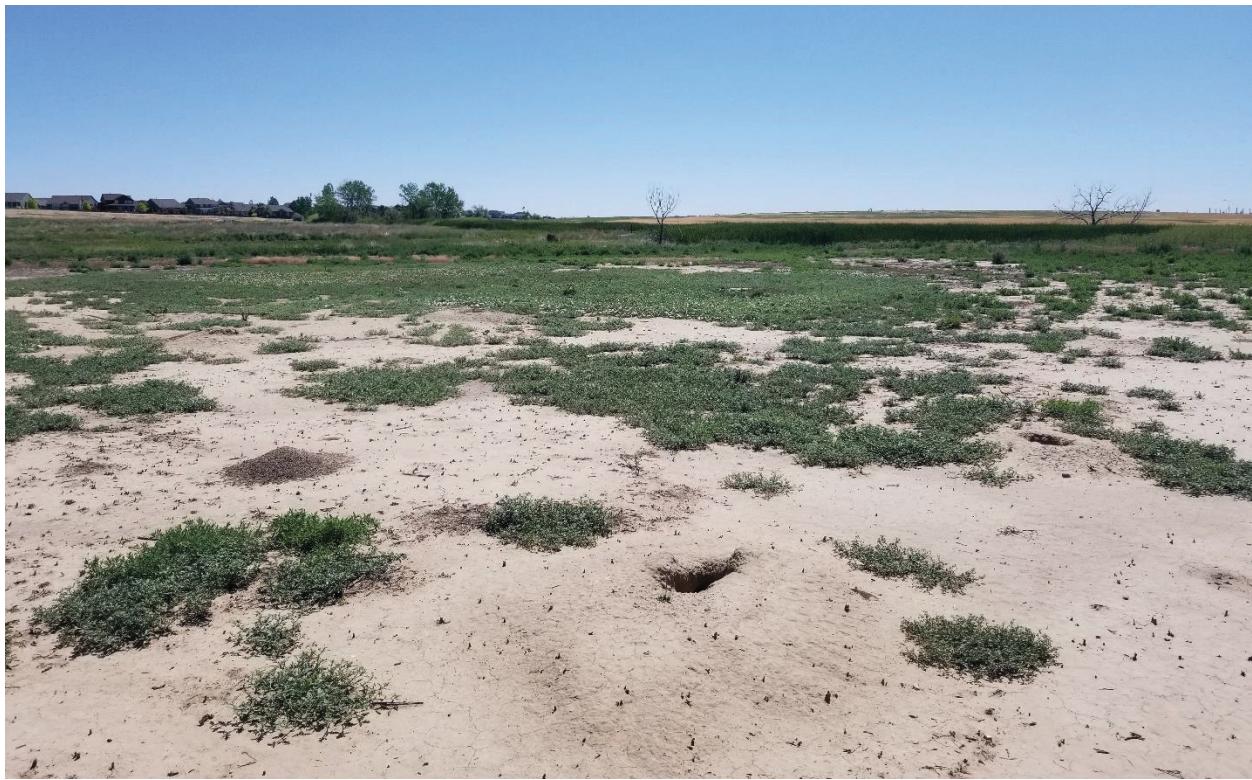
Additionally, prairie dogs are exacerbating the problems associated with the saline and sodic soils. When prairie dogs excavate their burrows, subsurface soils are often deposited on the surface. In natural settings, this can provide a vital ecosystem service by aiding in soil aeration and nutrient cycling. In the Study Area, however, prairie dogs are bringing soil to the surface from the most saline and sodic horizons in the soil profile. This has resulted in even higher salinity and sodicity conditions at the surface in areas where prairie dog burrows (active or inactive) currently exist. These high salinity and sodicity levels have a pronounced effect on vegetation, and in some areas, plant cover is almost nonexistent (Photo 7).

**Photo 7.** View looking east on Avar soils west of Second Creek with bare ground and weeds, primarily field bindweed and Russian thistle. Prairie dogs were present in this area.

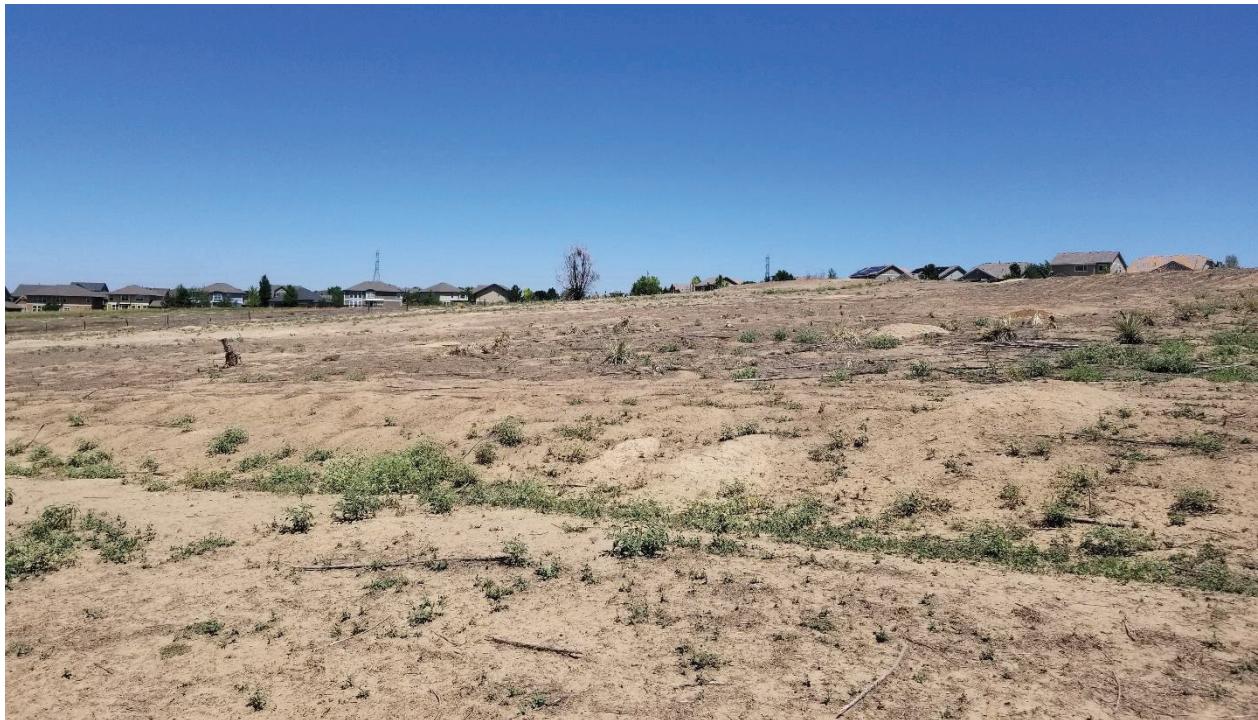
**Photo 8.** View looking east at Vona soils on the hillside on the eastern edge of the Study Area. Where vegetation is present, it is primarily field bindweed. Prairie dogs were present in this area.

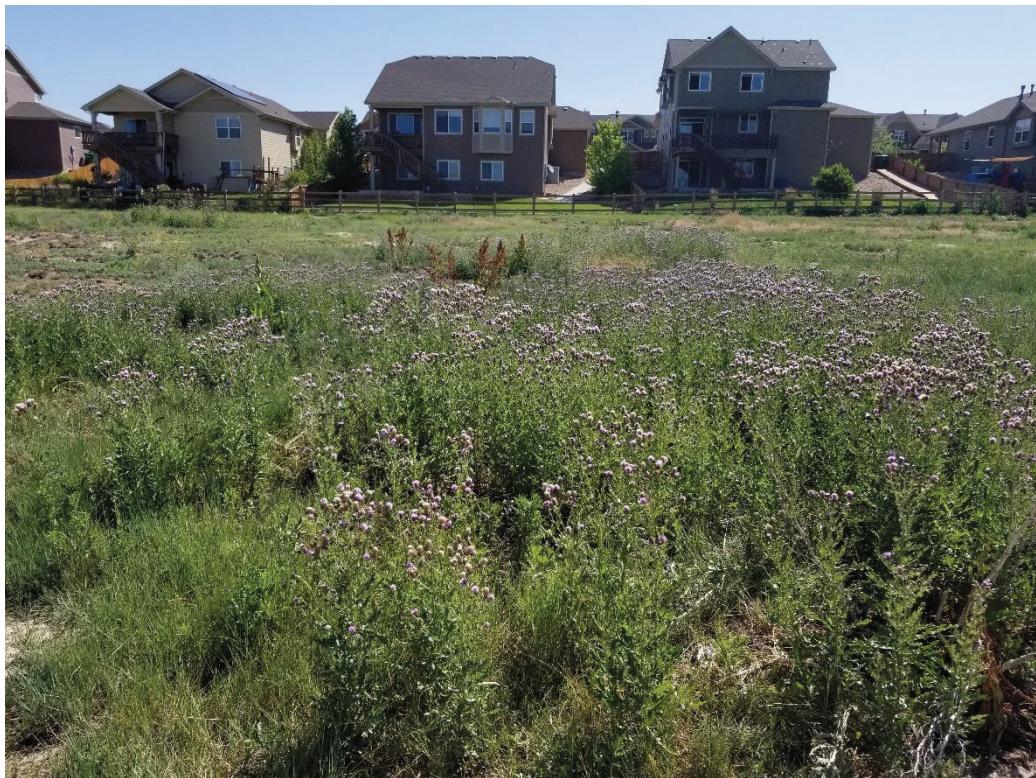
**Photo 9.** A large infestation of Canada thistle, a state-listed noxious weed.

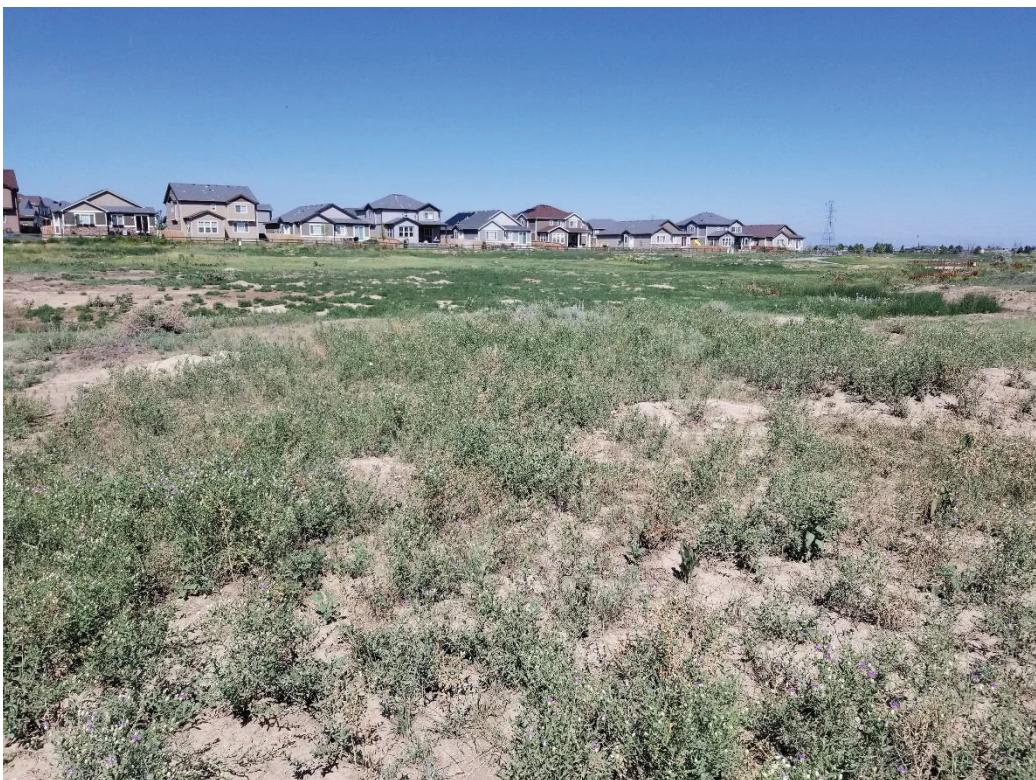
**Photo 10.** Avar soils supporting a large infestation of Russian knapweed, a state-listed noxious weed.
