Condition of Turf in City Parks

Overview

2020 Turf Conditions Throughout the Parks System

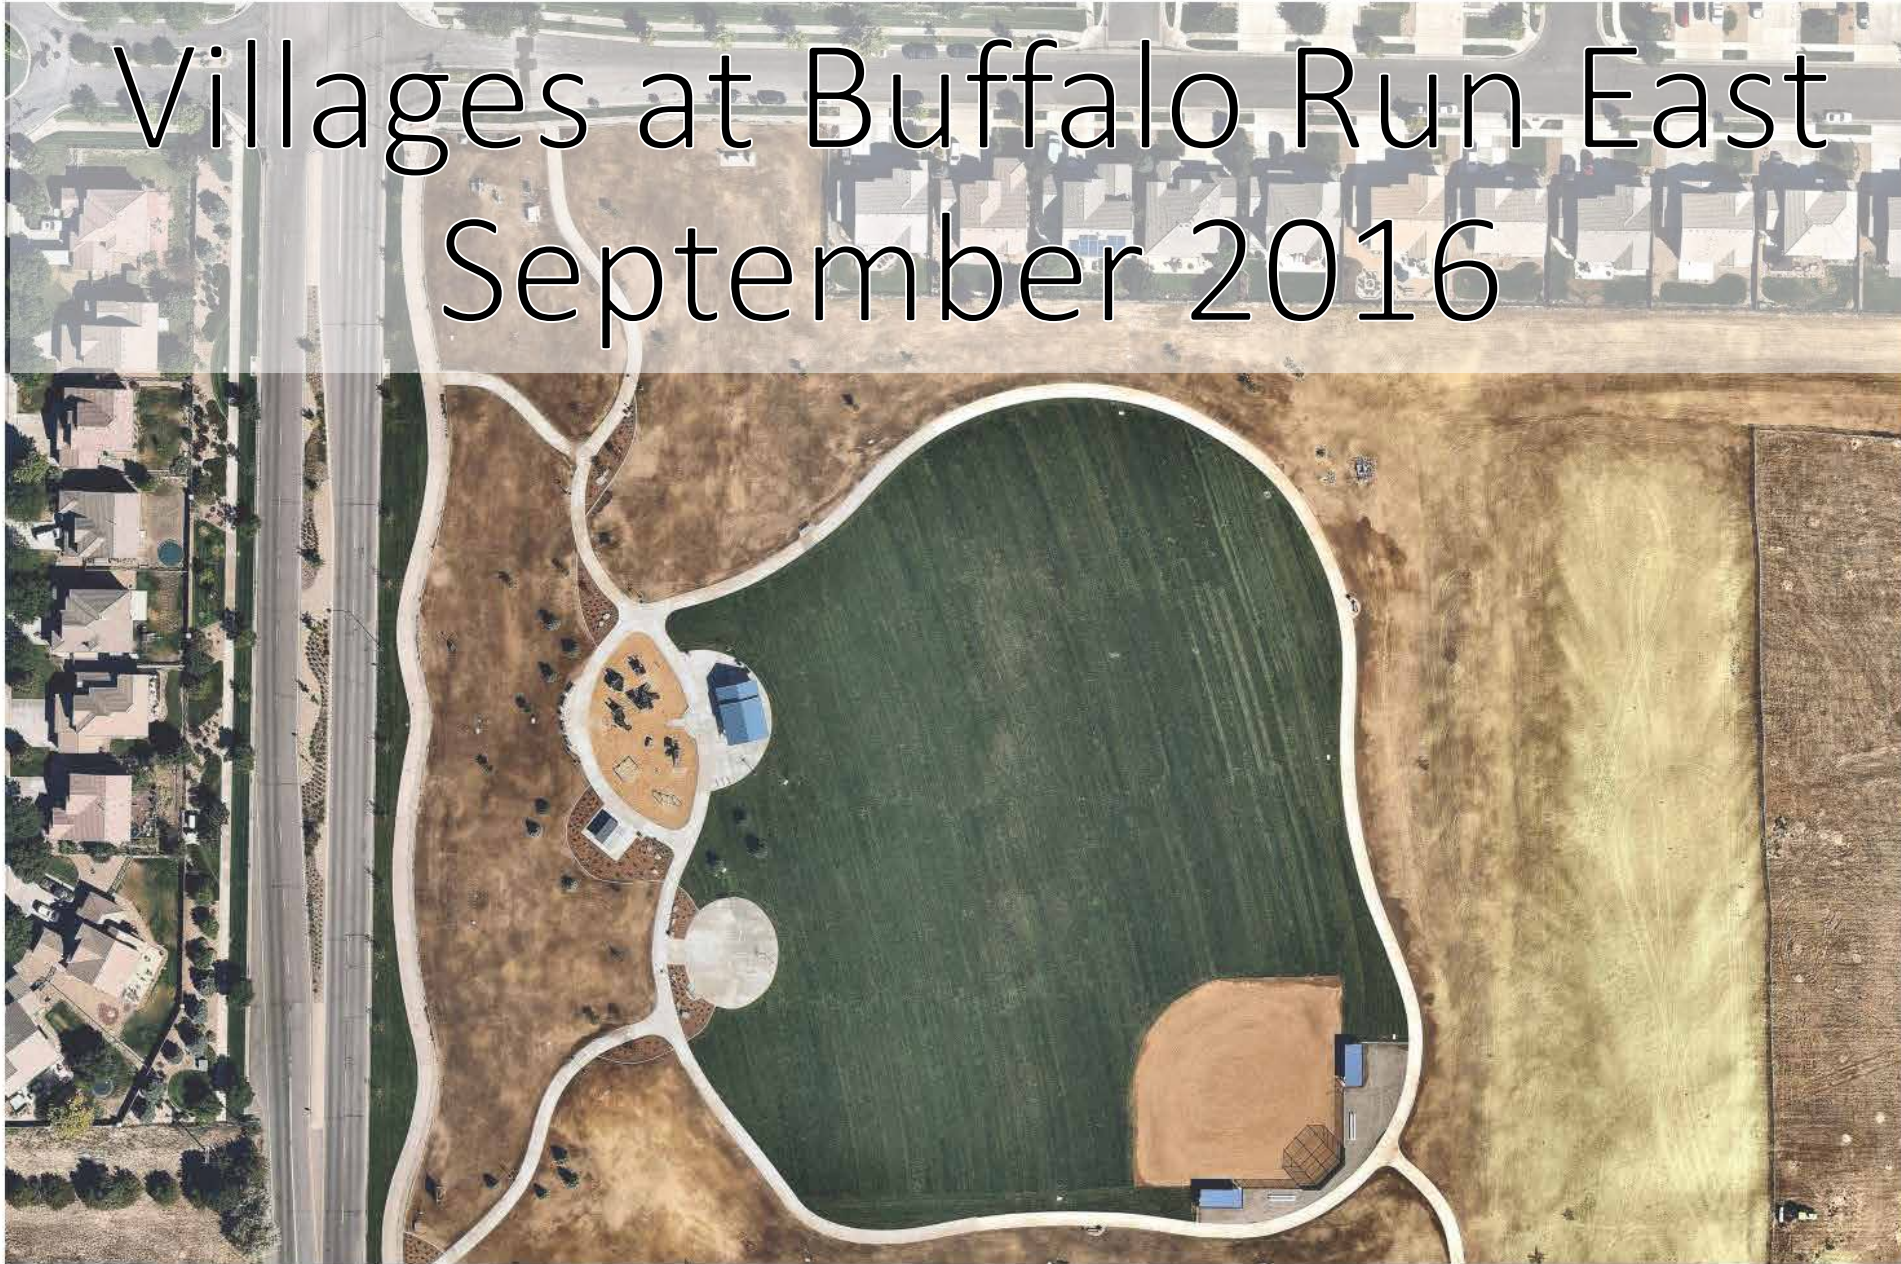
September 2016

Villages at Buffalo Run East

- Sodic Clay Soil Conditions (extremely high Sodium content)
 - Levels several times higher than upper limit for grass growth
- Similar conditions exist at Stampede Park (VBRW), Buffalo Run Golf Course, Second Creek Open Space
- Consulted with Agronomists, soil experts, leading golf and horticulture industry consultants
- Soil and irrigation water analysis

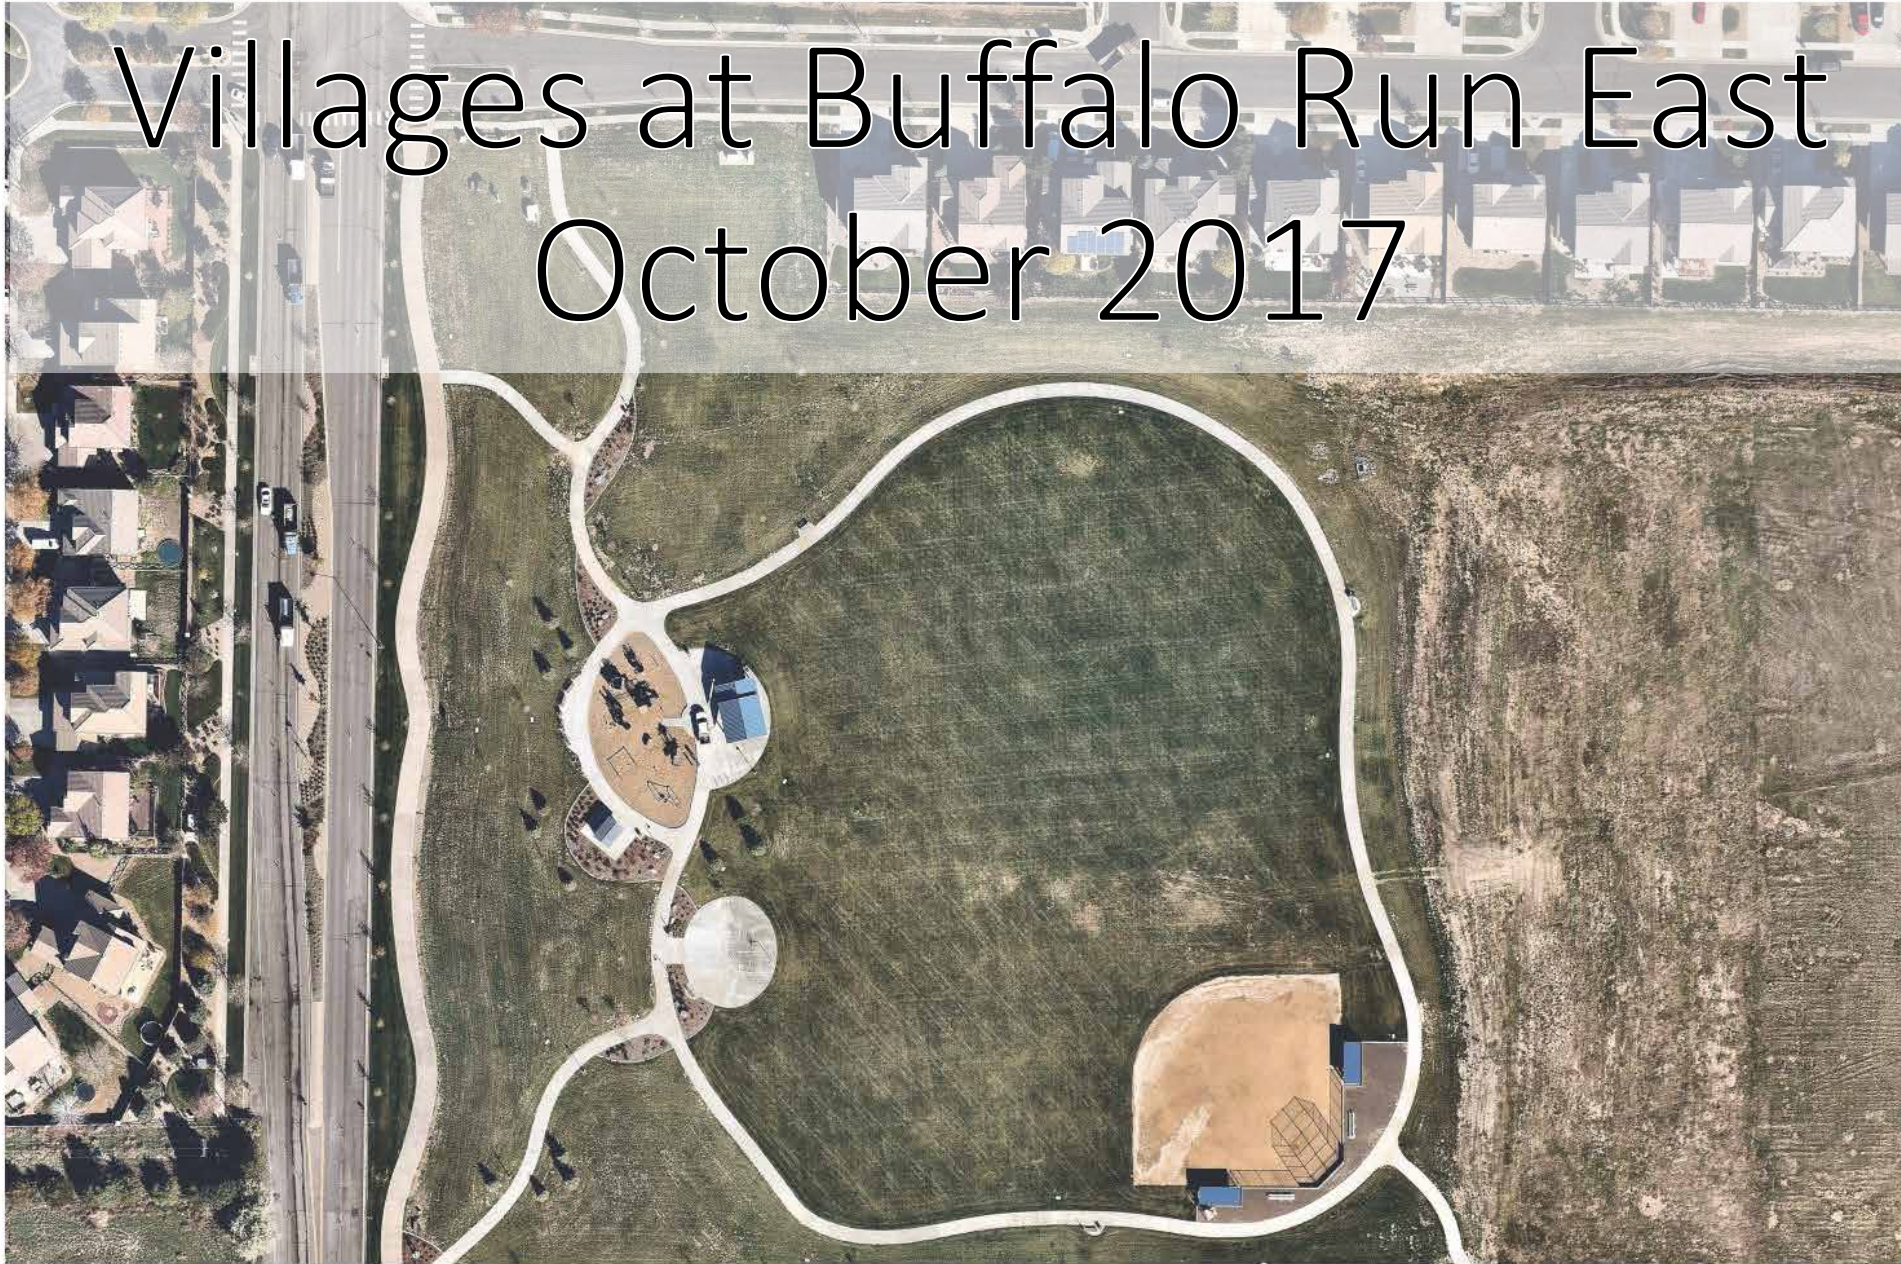
October 2017

Villages at Buffalo Run East

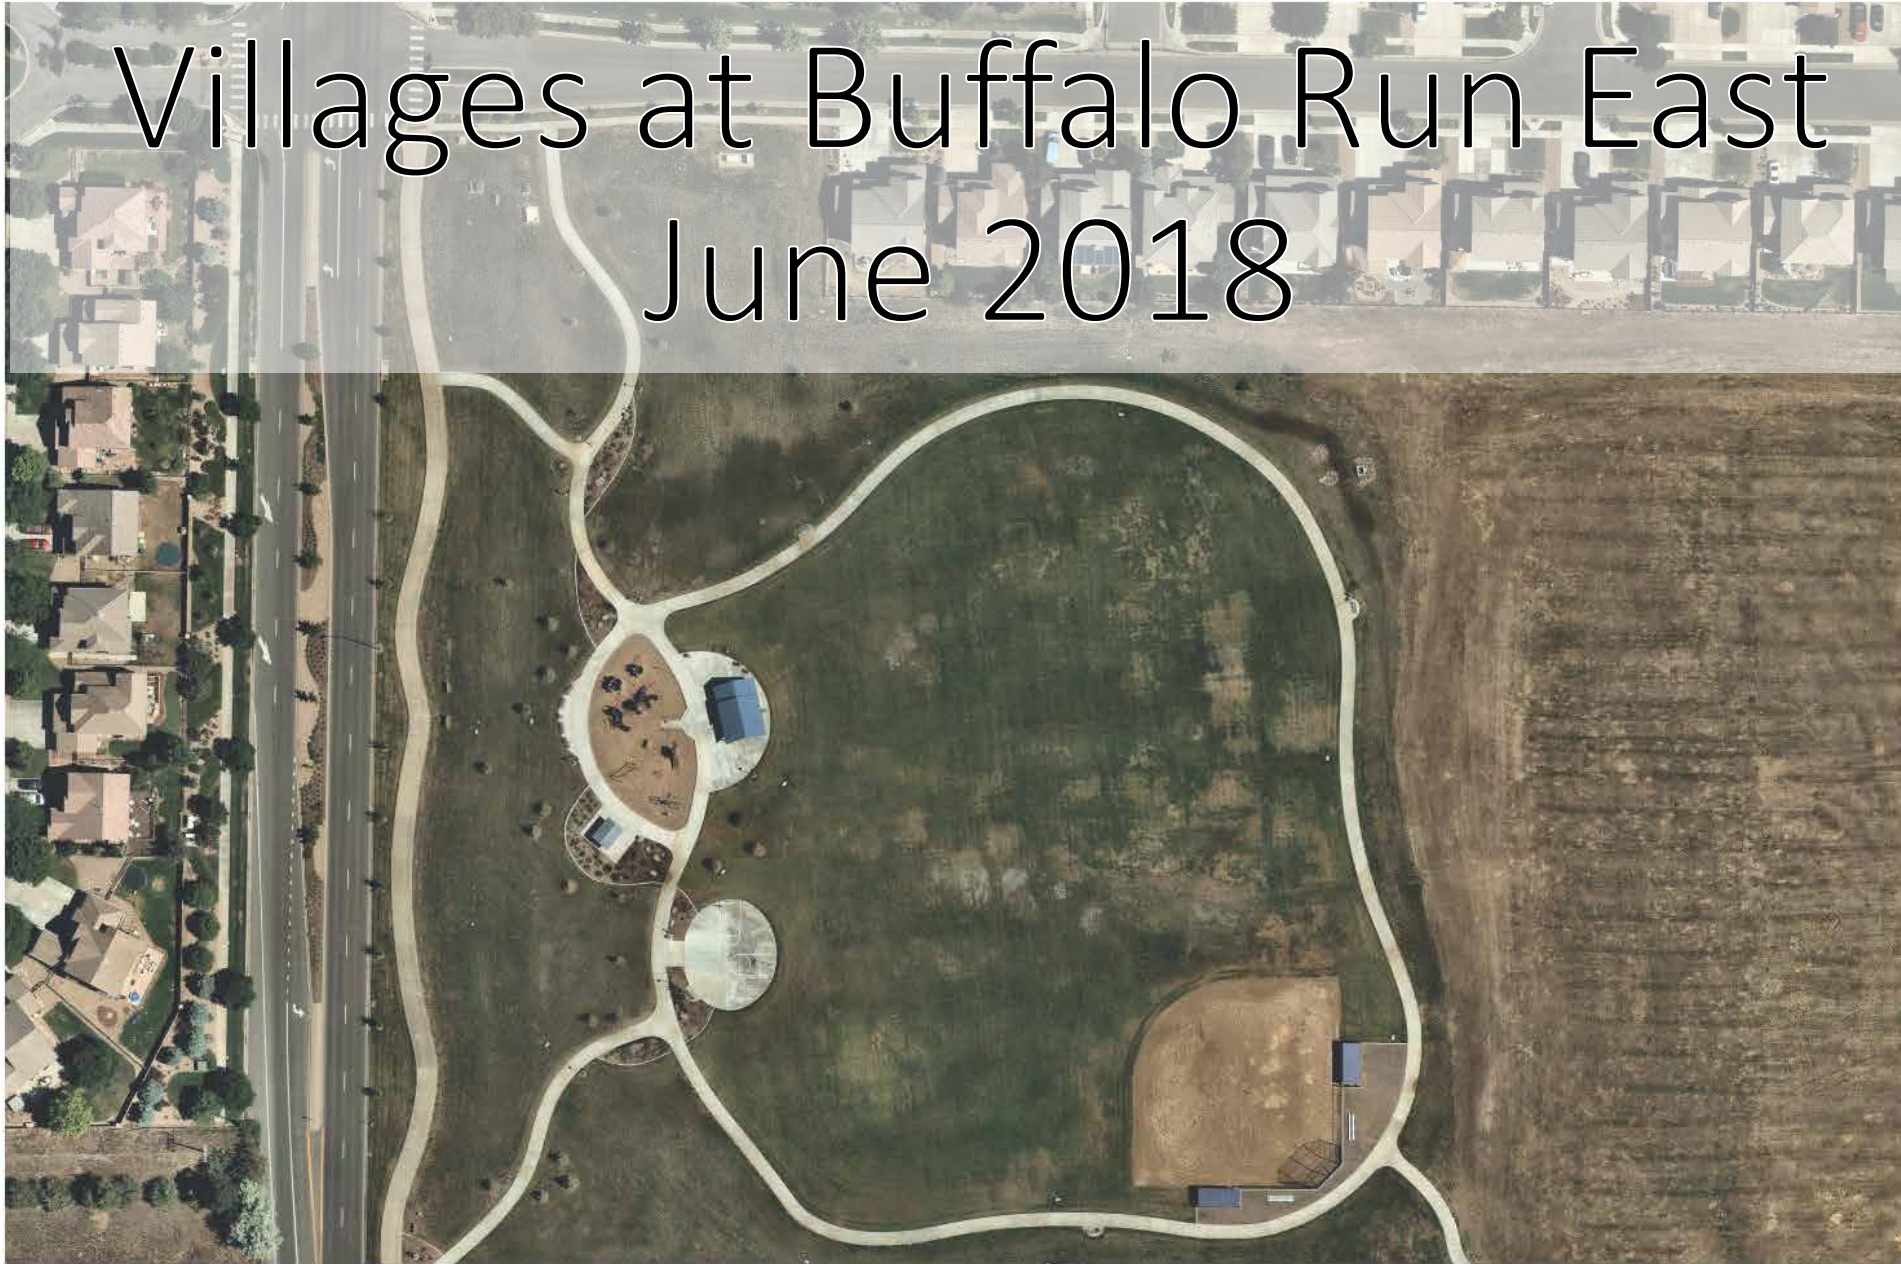
June 2018

Villages at Buffalo Run East

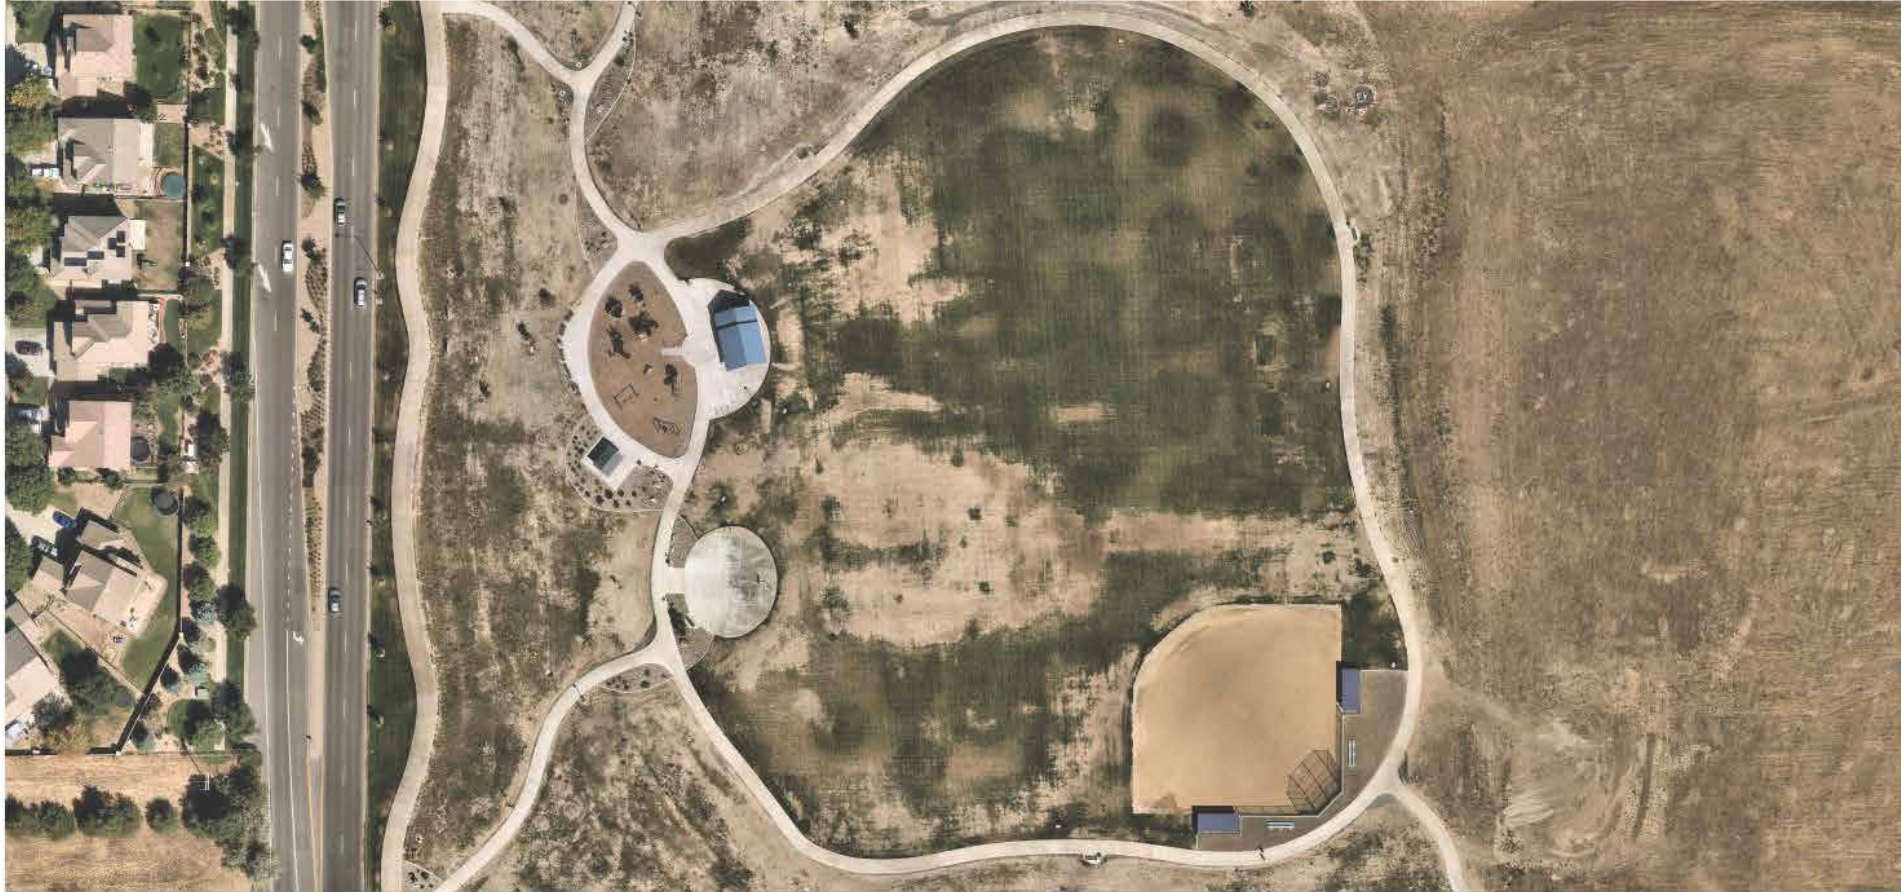
September 2019

Villages at Buffalo Run East

- Changing the Soil Profile and Composition
 - Drill and Fill Machine Purchased
 - 24 drill bits: 1-1/4" wide x 12" deep, 7.5" on center
 - Removes soil, fills holes with sand
 - Gypsum applications (multiple applications per year)
 - 1.5 tons per acre
 - Cation exchange
 - Soil conditioners to off set irrigation water deposits
 - Water treatment system (injection pump)?

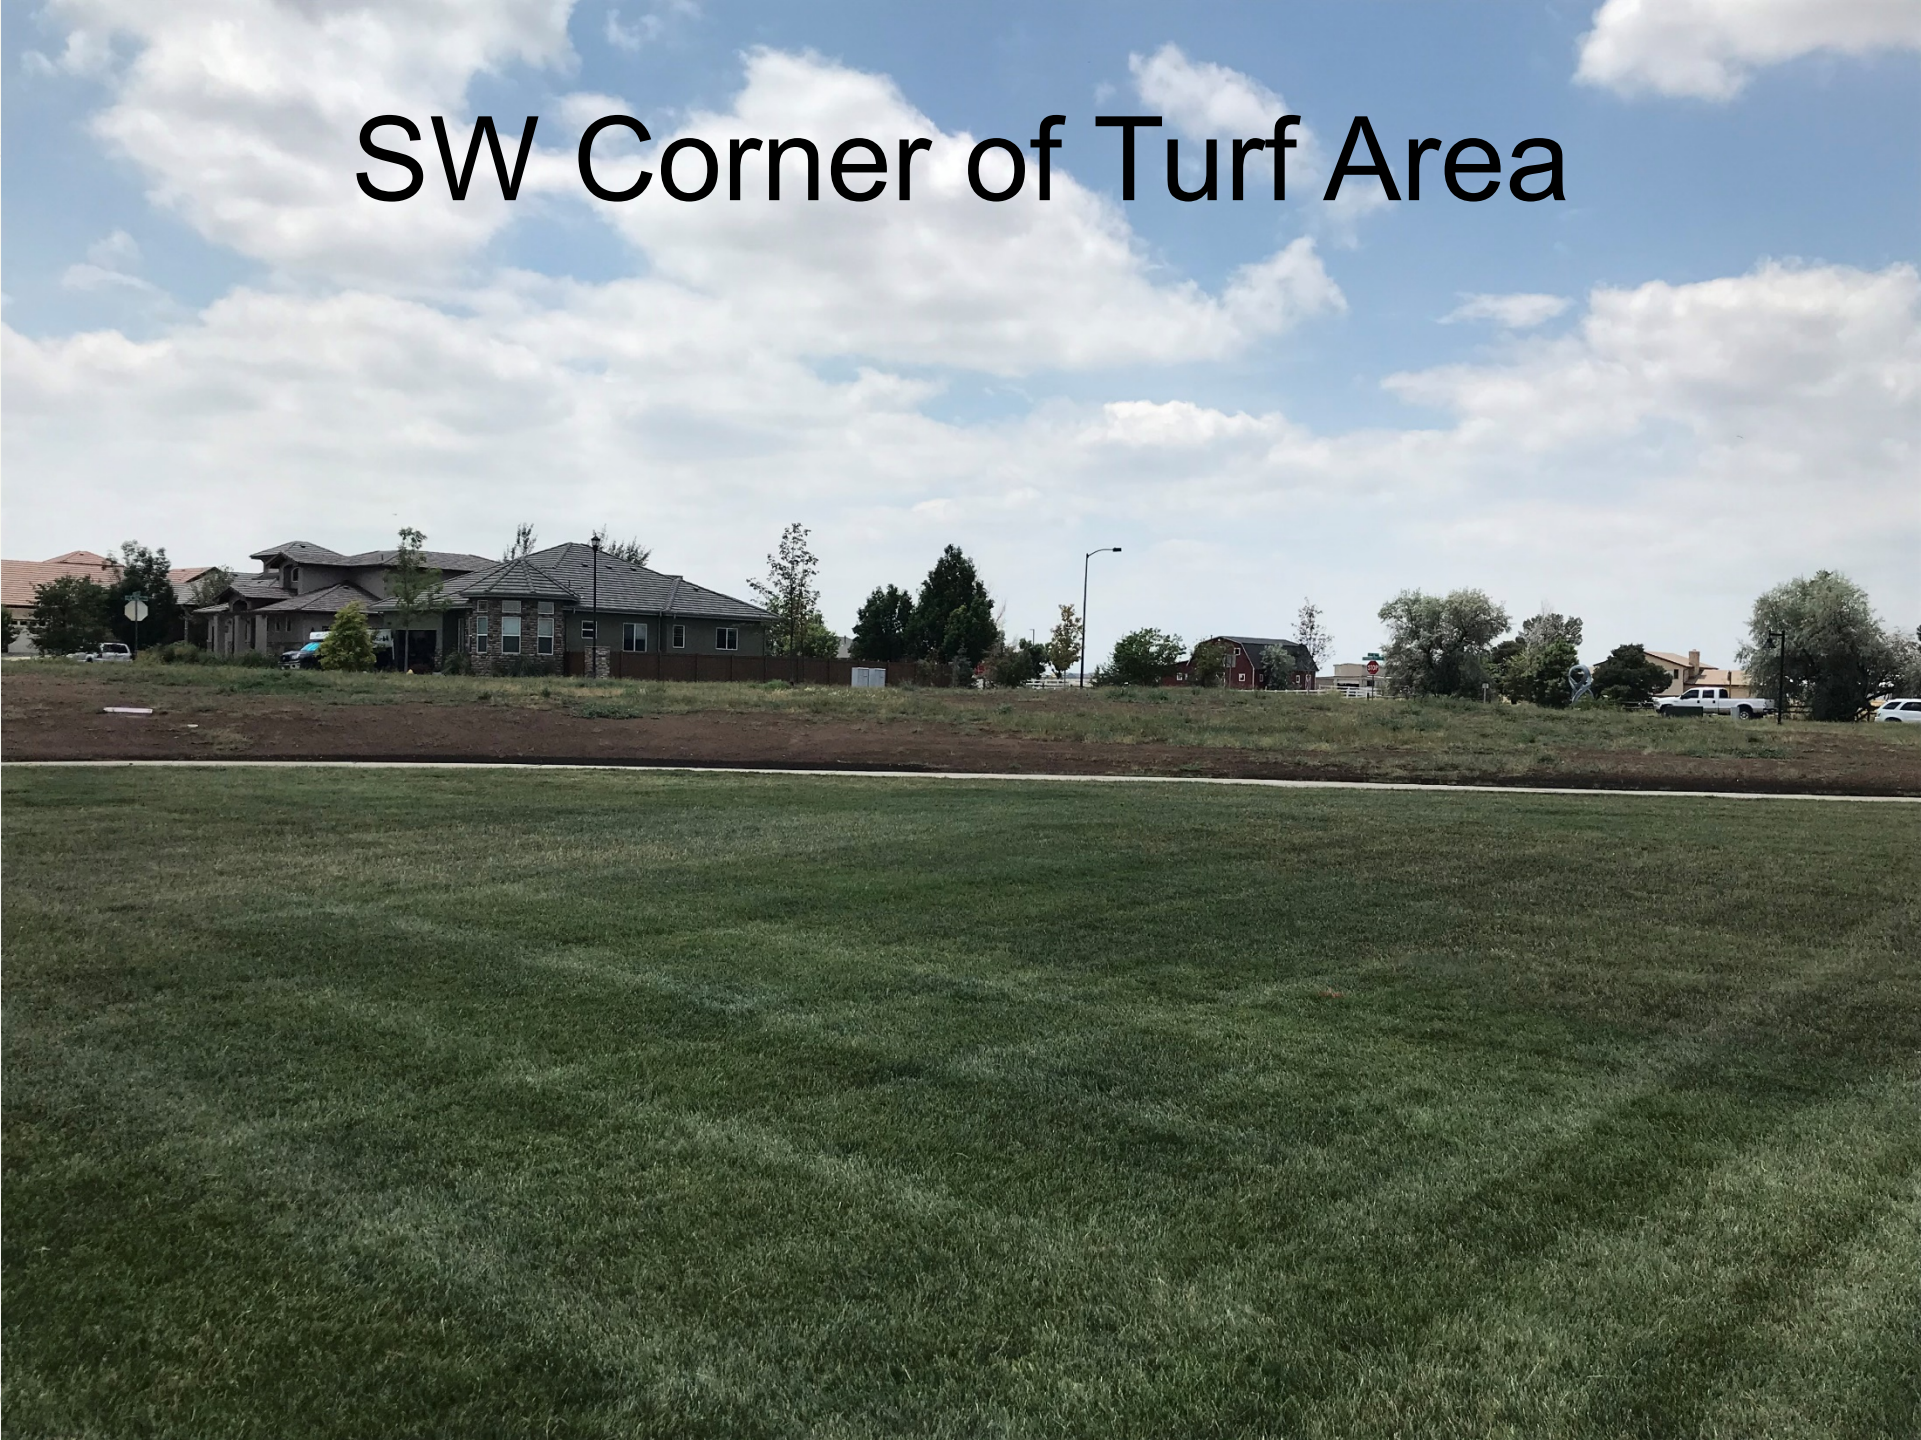
SW Corner of Turf Area

- High rate of seed germination
 - Areas filling in from seed progressing to multiple leaf stages and building healthy root structures
 - Areas filling in nicely with seed and grass blade propagation
- Drainage of soil
 - Minimal issues with standing water after large rains or irrigation that resolve themselves by draining into/through the soil

- Continue to follow practices that are showing good results for turf areas
 - Drill and Fill seasonally as necessary/able (2-3/season)
 - Monthly topdressing and gypsum applications
 - Frequent aerations (deep tine - monthly)
 - Soil sampling
 - Fertilization (spring, summer, fall)
 - Heightened irrigation system monitoring and fine tuning
